**State Bar of Arizona Task Force on Persons With Disabilities  
Accessibility Committee Site Visit  
Graham County Superior Court  
City of Safford Justice Court  
Safford, Arizona**

**SURVEY BACKGROUND**

**Facility:** Graham County Superior, Safford, Arizona, and the City of Safford Justice Court

**Date:** May 25, 2004

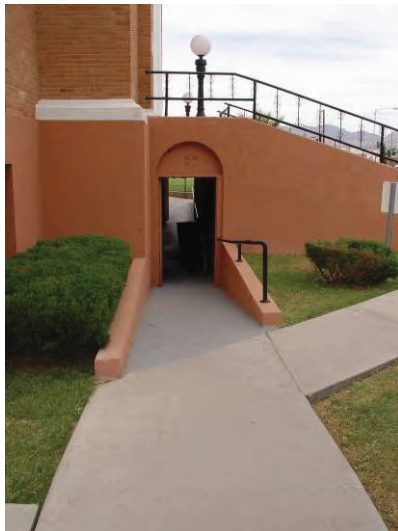
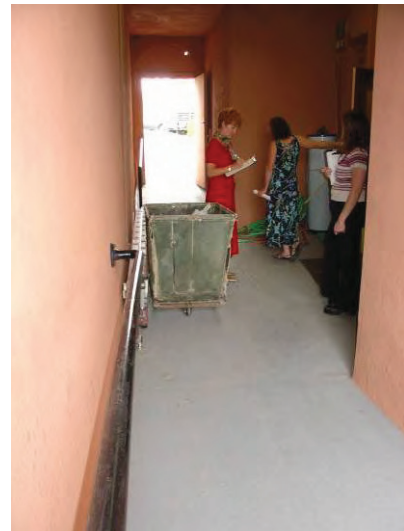
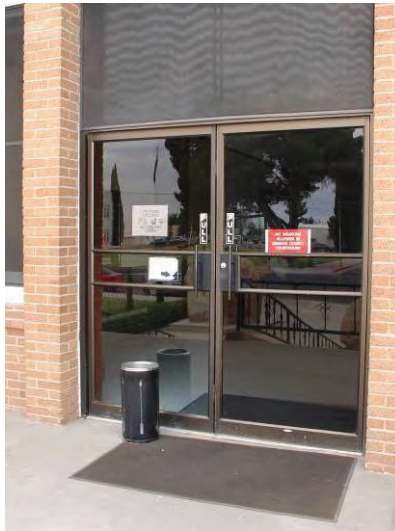
The main accessible entrance was challenging, but functional. The accessible entrance is behind and underneath the main court entryway, and opens into the basement of the building. The accessible entrance is not an automatic door, and also functions as the delivery entrance, which is not uncommon for many of the courthouses visited, or even a criticism; if the entryway can be commercially useful for purposes other than accessibility considerations, then it confirms the wisdom of universal design. While no signage indicated the availability of an accessible entrance, the railings leading down the ramps to an opening underneath the main stairway entry to the court, were clearly visible. On the day we visited, some maintenance and construction materials were in the entry area, but did not appear to present an obstruction to the entryway.

The accessible entrance could be a lighter tension, but was slow-closing, which is helpful for persons with mobility challenges. Light tension doors can be used at entrances, without the door being subject to wind or air pressure pulling it open.

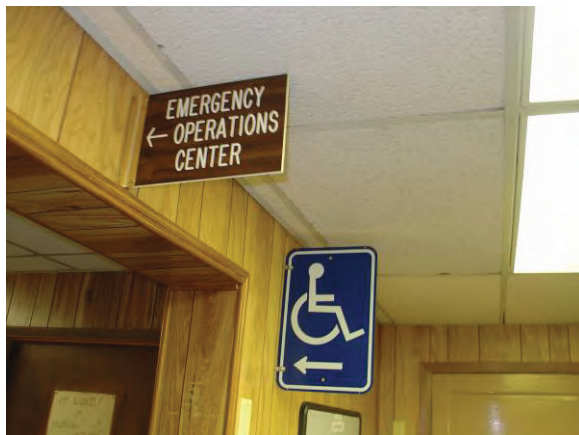
There were no evacuation maps or procedures posted, but a sign indicated an emergency exit which is accessible. Administrative staff would assist members of the public, including persons with disabilities, during any evacuations. The fire alarm handles seemed somewhat high for a smaller individual or someone using a wheelchair or walker. There is no Braille associated with the fire alarms or with any emergency exits. Persons with disabilities would be very dependent on courthouse staff in the event of emergency, who appear helpful and available.

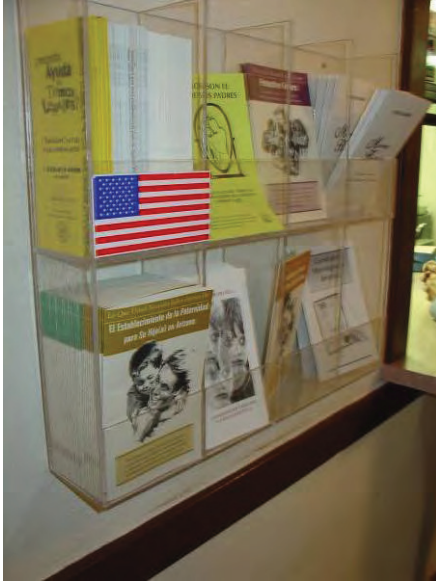
While the informational bulletin shelf at the entrance to the Courthouse was outstanding, there is no pamphlet currently available describing services for persons with disabilities. However, this was consistent with most of the courthouses surveyed in Arizona.

Similarly, and consistent with any budget demands, some consideration could be given to publishing a pamphlet for members of the public or those in the legal profession with disabilities.

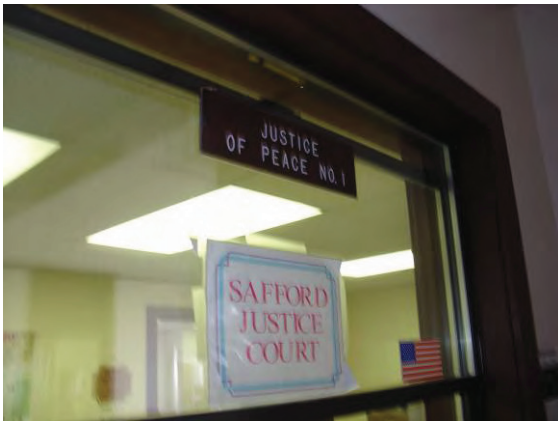
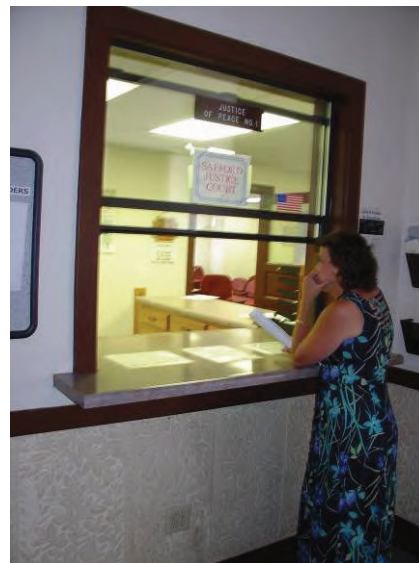
The Safford Justice Court Clerk's window presented access challenges to any person of low height or using a wheelchair.

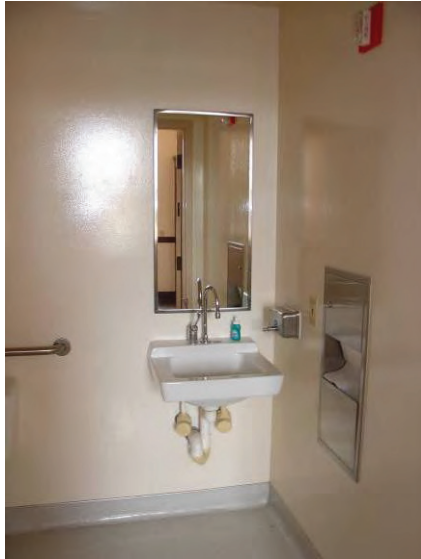
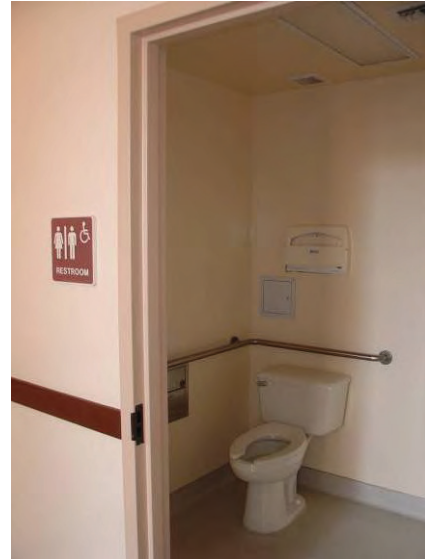
The restrooms were accessible on all floors. All restrooms seemed accessible with no significant issues or concerns noted. The sidewall placement of soap dispensers was optional, mirroring the survey's recommendation for sidewall placement to permit persons in wheelchairs or with low height to reach the dispensers without excess soap materials falling on the floor and creating a slippery surface. The lower level bathroom did not have a heat-protection pipe wrap.

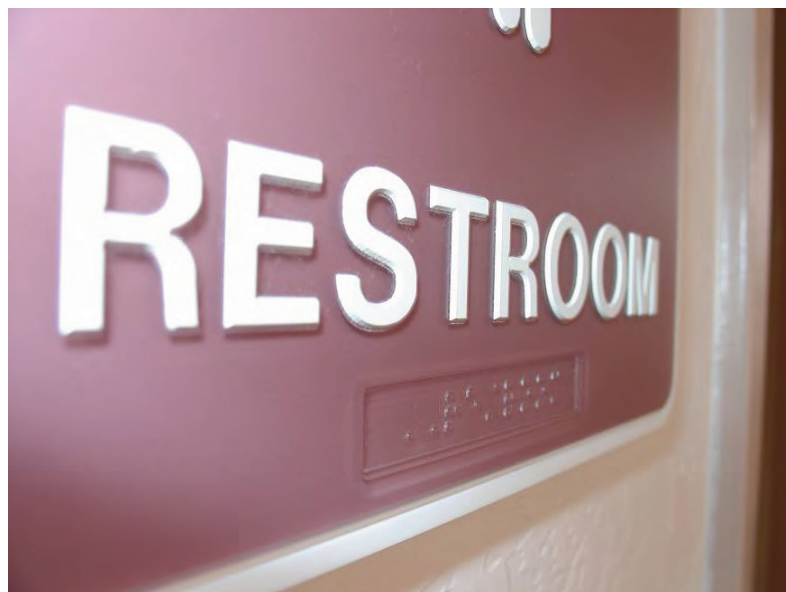
The third floor has a unisex bathroom, but with Braille description. Braille identified all of the bathrooms in the building. That bathroom was fully accessible, including wheelchair entry and exit space, heat wraps on the sink pipes, and a soap dispenser to the sidewall, making it easier to reach.

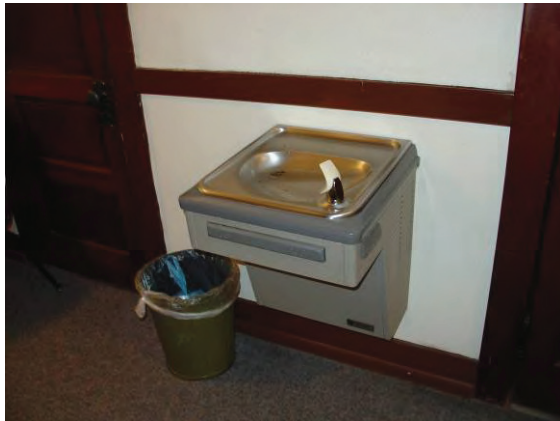
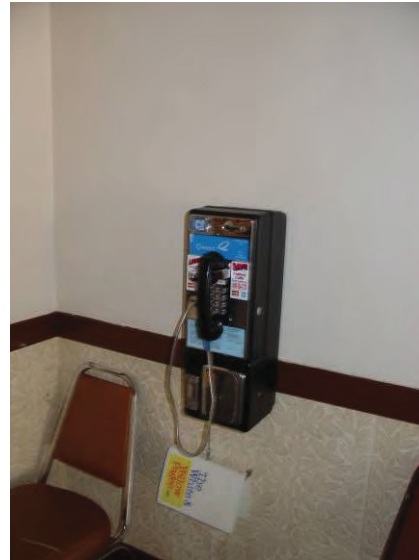
All hallways were wide.

Each floor that the team observed had a water fountain at wheelchair height, and all were functional.

The public telephone was placed at an accessible height, with TTY capacity.

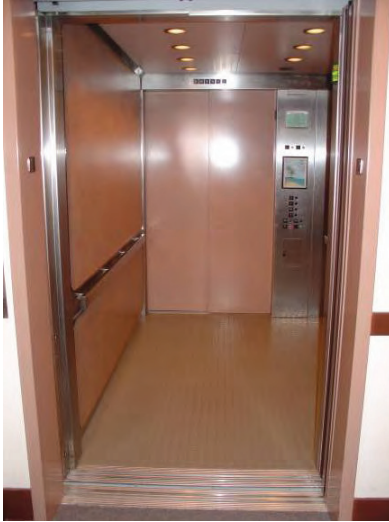
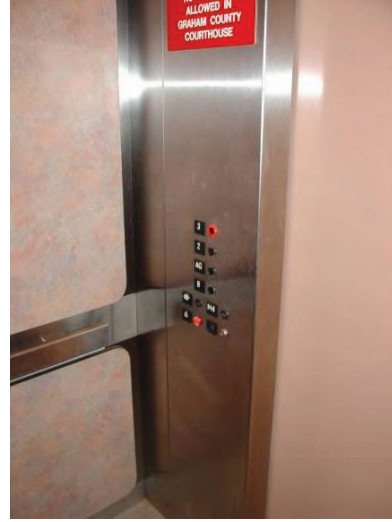
The public elevator is large, with a railing inside. There was sufficient room in the elevator for entry and mobility, and the elevators had a non-slip, rubber tile surface that was extremely safe and functional. The buttons were placed at appropriate heights. The elevator floor indicators outside the elevator were in Braille.

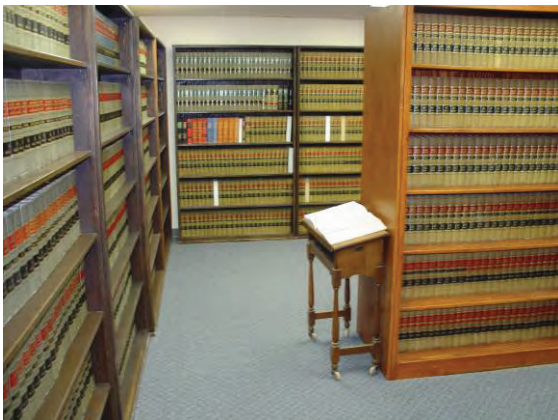
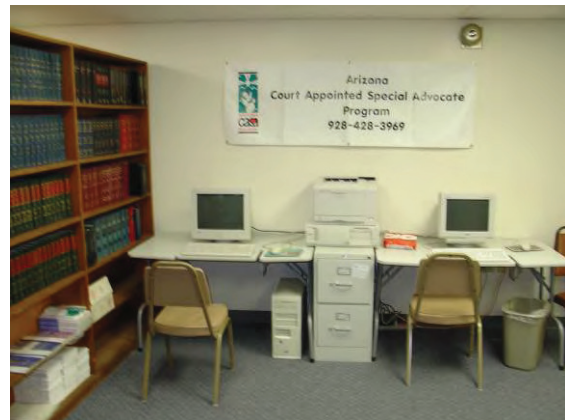
The law library is located on the bottom floor and was quite functional for a person using a wheelchair or generally having mobility challenges. The library is open to both staff and members of the public. The library was moved to the bottom floor because of the heavy weight of the books, reflecting the degree to which the courthouse staff was working with an older structure. It has a fully accessible water fountain at wheelchair height and electronic research facilities. A large banner was prominently displayed in the library for a Court Appointed Special Advocate, with a telephone number, with a scope of assistance that presumably would benefit persons with disabilities.

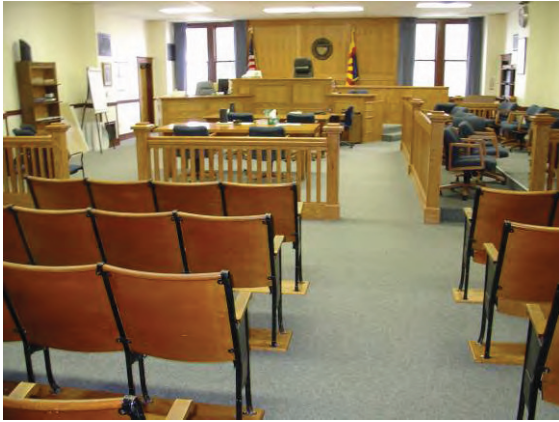
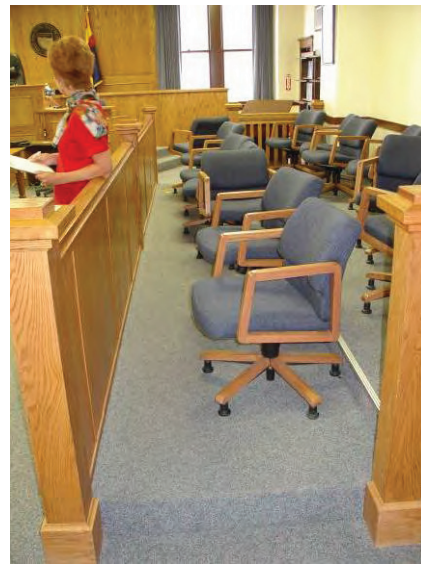
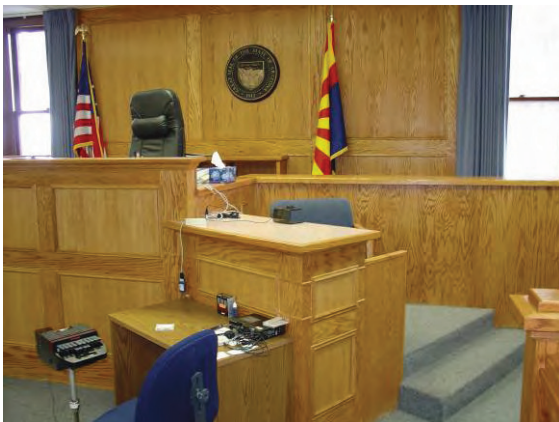
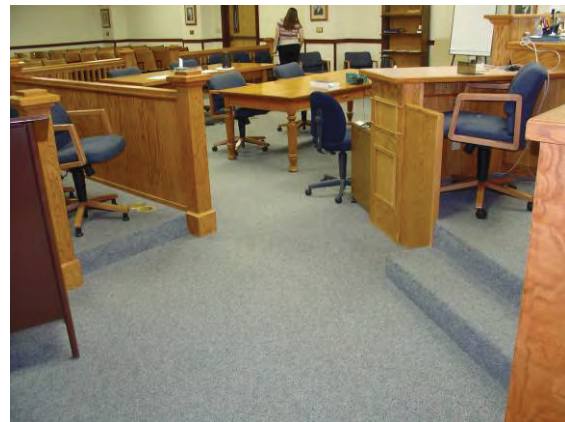
Courtrooms are located on the main and basement floors. The upper level courtroom is partly accessible to members of the judiciary and public, and partly not. There are two steps, without a ramp, leading to the witness stand. There is one step, without a ramp, leading to the first observation tier of the jury box and a second step leading to the second observation tier. There is no gate separating the public gallery from the courtroom well, with two easily-passable entrances. The jury box only has chairs on casters, which may be easily moved to accommodate a juror using a walker or other mobility assistance. There is sufficient room in the gallery for numerous users of wheelchairs to easily move and observe proceedings immediately behind the railings.

The doors in and out of the courtroom, with two entrances for the public, all had crash bars. The main entryway doors were medium tension, but had a post between the two, for both security and noise control purposes. While representing a common courtroom design throughout Arizona, the barrier would present somewhat of an obstruction both for persons using wheelchairs and attorneys moving exhibits in and out of the courtroom. The door tension is initially medium, and increases towards 90 degrees extension. A common experience in reviewing courthouses in Arizona is that any door with a maximum extension of 90 degrees commonly is difficult for even a normal user to pull open past approximately 75 degrees.

The courtroom “well” was large. Castered chairs at the counsel table are easily removed to accommodate a wheelchair. The area behind the counsel table is large and open, permitting wheelchair use if necessary.

The Graham County Courthouse is a generally accessible building, both in its main areas of public use and in its courtrooms. Personnel responsible for administering the facility seemed aware of the needs of persons with disabilities. The historic courtroom presents a challenge for accessible use, with the simplest suggestion being a removable ramp to the witness and jury boxes.

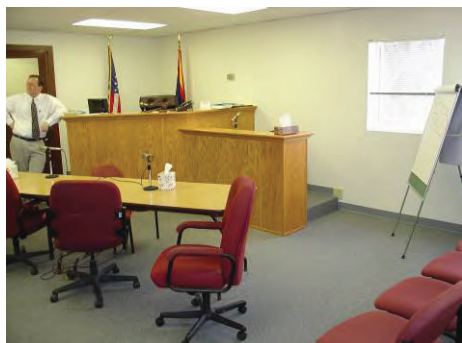
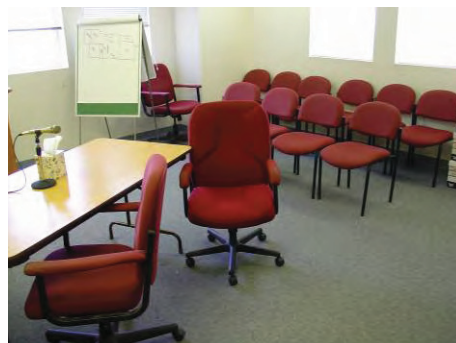
The Justice Court Courtroom was essentially accessible, once again demonstrating that the more basic the courtroom elements, the more accessible the facility generally is. There was no jury box, with four rows of ordinary chairs supplying that instead, any of which could be removed or moved to accommodate a person with a mobility disability or using a wheelchair. The same is true for the table and chairs constituting counsel’s table. The witness stand had one step.

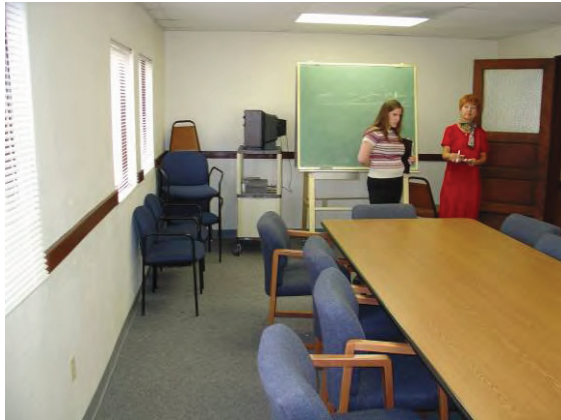
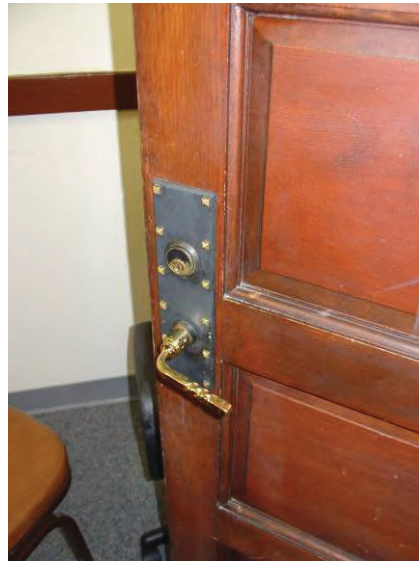
The jury deliberation room on the upper level Courtroom floor was somewhat small, but did appear accessible in all material respects. The jury deliberation room doors have ornate, but accessible “wing” or latch handles.
