**State Bar of Arizona Task Force on Persons With Disabilities  
Accessibility Committee Site Visit  
La Paz County Superior Court  
Parker, Arizona**

**Facility:** La Paz County Superior Court, 1316 Kofa Avenue, Parker, Arizona 85344

**Date:** June 4, 2004

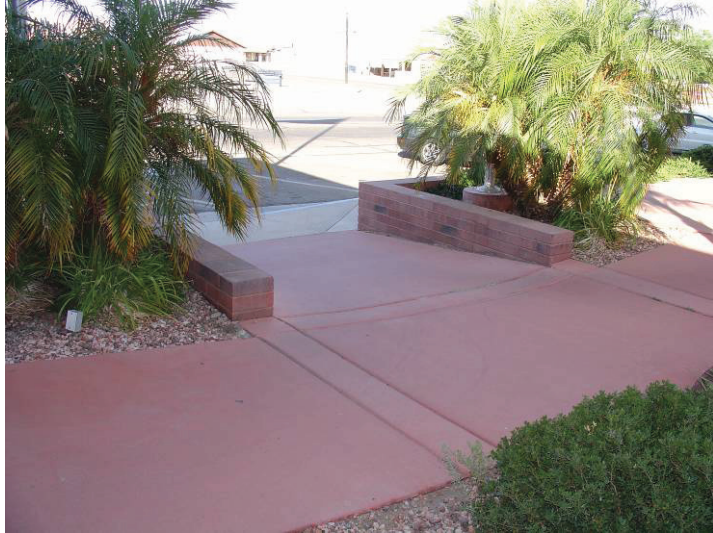
The overall impression is that this is a facility in a newer complex that was designed to have the look and feel of a more historic adobe structure. As Ms. Newman noted, it was constructed more for aesthetics than for functionality or accessibility. The Superior Court and Justice Court occupy two separate suites in this complex. Due to the late hour of the team's arrival, our tour concentrated on the Superior Court facility. The team did, however, note a very nice ramp to the entry of the Justice Court.

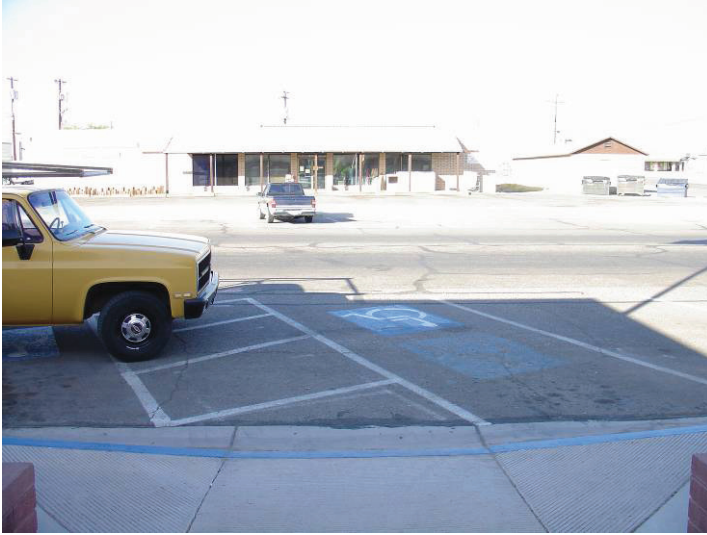
The parking lot is somewhat inconveniently located from this facility. There are some accessible spaces on the street immediately outside the facility; however, one has to negotiate a steep and short ramp up from the street. Ms. Newman noted that an employee who had temporarily used a wheelchair had to back the wheelchair up, using one foot to propel herself, in order to maneuver this ramp. This would not be a viable option for many persons using a wheelchair. The team noted that this should be changed, if possible.

Suggestion: If possible, change access from accessible parking on street level to avoid use of steep, short ramp.

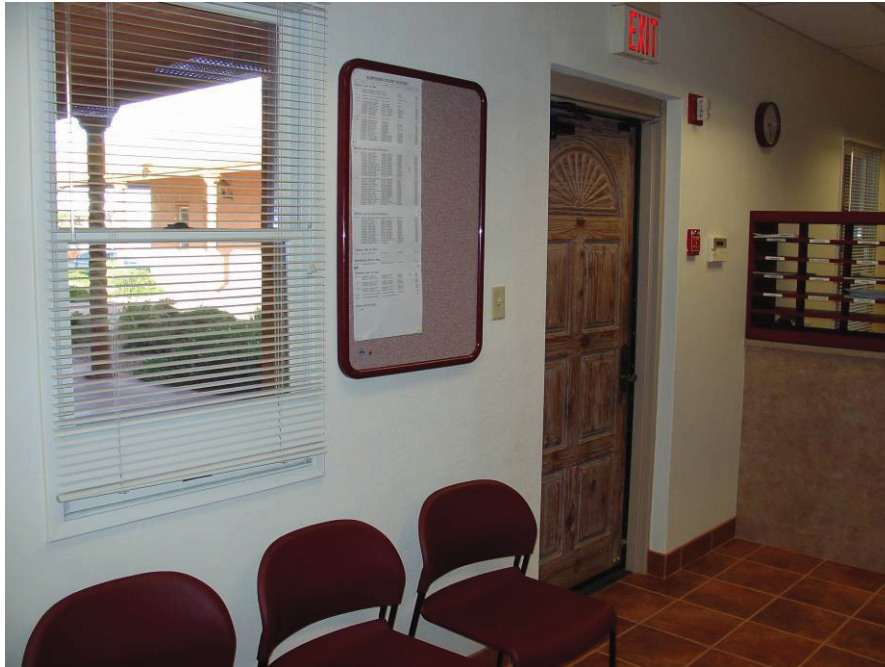
The lobby is flanked by an open counter area. Given the relatively young age of the facility, it was surprising to find that none of the counters had been lowered to provide access by individuals using a wheelchair. The team also noted that fire alarm pulls are too high to be accessed by an individual using a wheelchair.

The team noted Braille on many of the posted signs inside and outside the facility. There was no apparent signage directing those needing assistance or accommodation to a contact person; however, as individuals approach a staffed open counter area immediately upon entry, they can ask the staff person assisting them for this information.

The lobby is still undergoing some changes from more recent remodeling, and Ms. Newman noted that some further enhancements are forthcoming. Lowering the counter is something which could be included in these changes.

Suggestion: Consider lowering a portion of the counter and the fire alarm pulls in the lobby so as to provide accessibility to a person in a wheelchair.

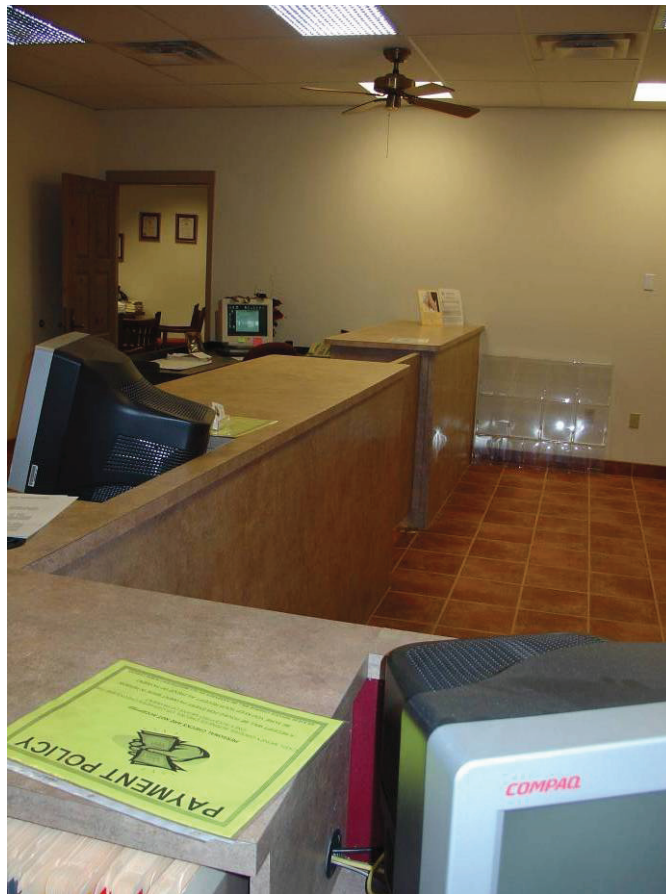
The team noted that court administration areas were generally accessible. Ms. Newman informed the team that they would do their best to accommodate anyone with a disability who required access to those areas. She noted they had made some minor accommodations for an employee who had to temporarily use a wheelchair for a couple of months.

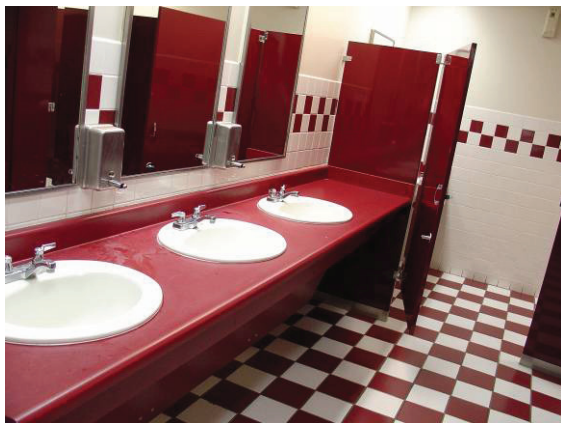
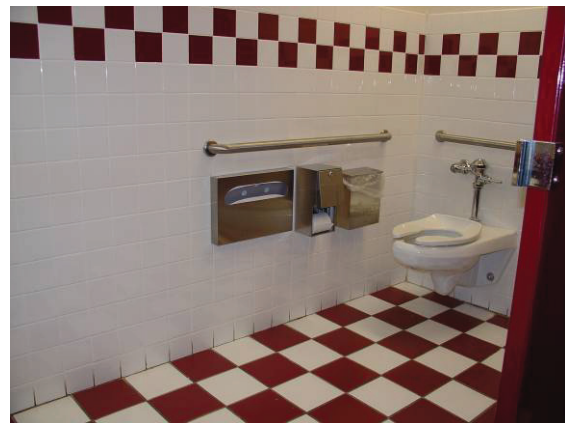
There are public restrooms for the entire complex that are located in a separate suite within walking distance from the court. These restrooms are very spacious and maneuverable. The handicapped stall in the women's restroom includes bars and its own sink, making use very convenient. All sinks had small flipper handles, which would allow for easier use by a person with a mobility disability. Boxes that hid pipes under the counters were appropriately sloped to allow for greater access by a person using a wheelchair. Soap and paper towel dispensers were at a good height to be readily accessed by all.

Suggestion: Exchange handles on internal restroom faucets to the flipper type.

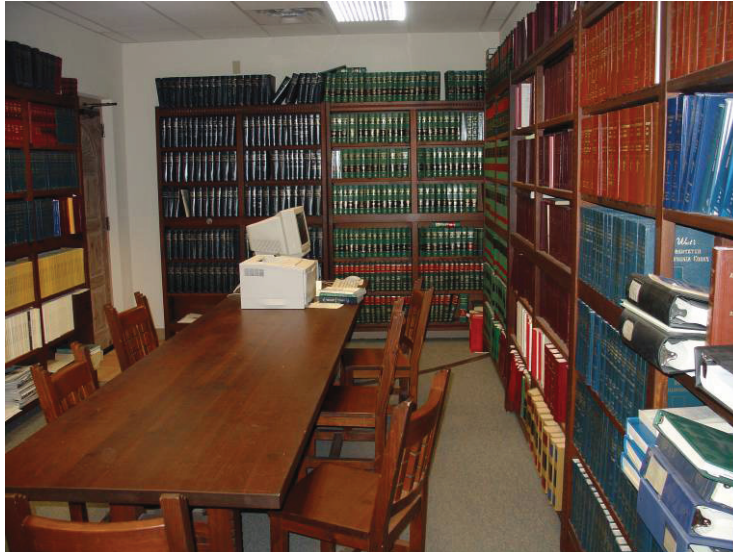
With an obvious emphasis on using space for different purposes, the law library, which is accessed through the Superior Court courtroom, is also used for attorney/client meetings, for administrative hearings, and as a waiting area for witnesses waiting to testify. In addition to containing some very interesting old texts, this room has computer stations at tables that can easily be accessed by a person using a wheelchair.

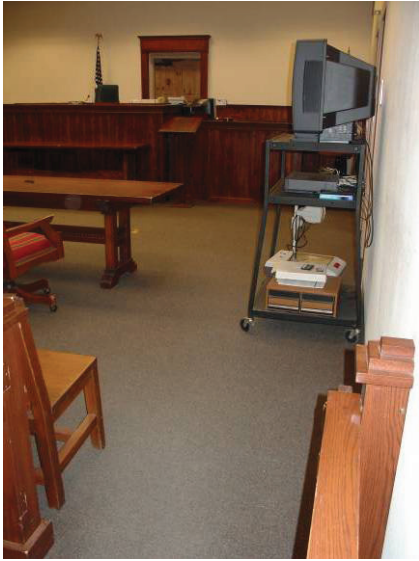
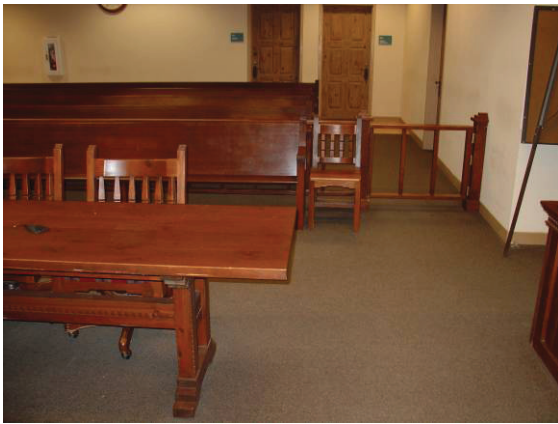
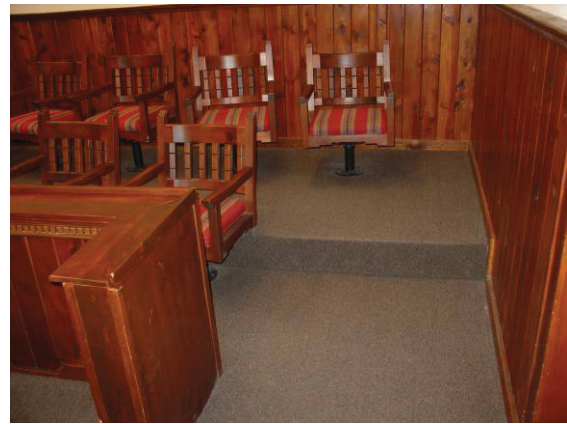
The Superior Court courtroom is a large and stately looking room. A real plus immediately noted by the team was the installation of a voice amplification system to assist an individual with a hearing disability.

The court bench, jury box and witness boxes are raised, so they would not be readily accessed by a person using a wheelchair. Ms. Newman explained that a witness with a mobility disability could be accommodated by placing the individual in front of the witness box. Ms. Newman also noted several other accommodations that would be made if needed, including the provision of a sign language interpreter for a defendant with a hearing disability. Such accommodations are made upon request to her office. Counsel tables easily accommodate individuals with disabilities.

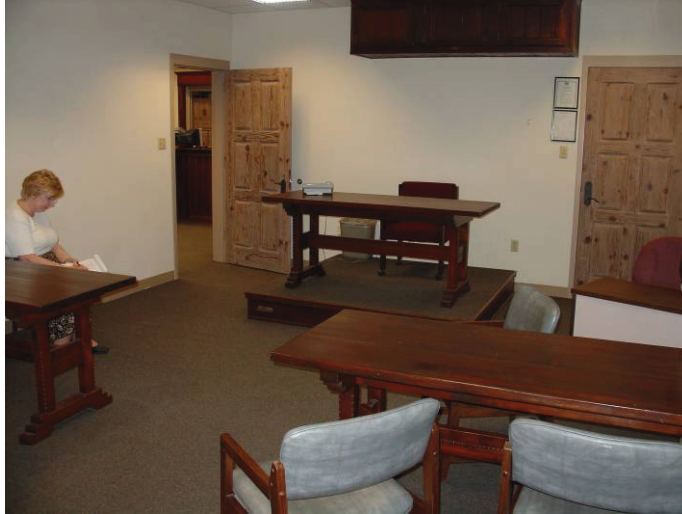
This is a small courtroom that is used for hearings, training, conferences, and motions. There is a platform bench that can be used as a bench or raised and stored so that all of the room is at one level. This is a great feature for room flexibility and full accessibility. Overhead storage maximizes use of space, but would be difficult for a person using a wheelchair to access.
