**State Bar of Arizona Task Force on Persons with Disabilities
Accessibility Committee Site Visit
Maricopa County Superior Court
Phoenix, Arizona**

SURVEY BACKGROUND

Facility: Maricopa County Superior Court, 101/201 W. Jefferson, Phoenix, AZ 85003; Original Courthouse, 125 W. Washington Street, Phoenix, AZ 85003

Date: February 24, 2004

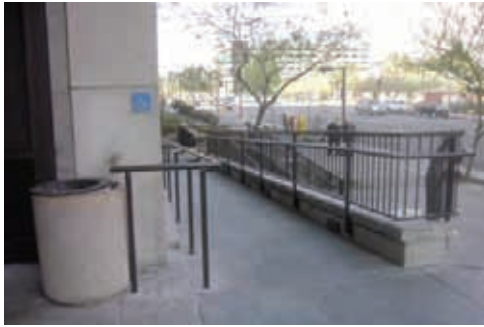
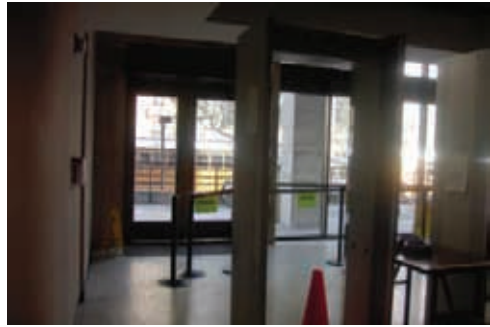
In several areas throughout the building, the universal accessibility signs are black and white. We recommend a switch to the more well known and recognizable blue and white signage.

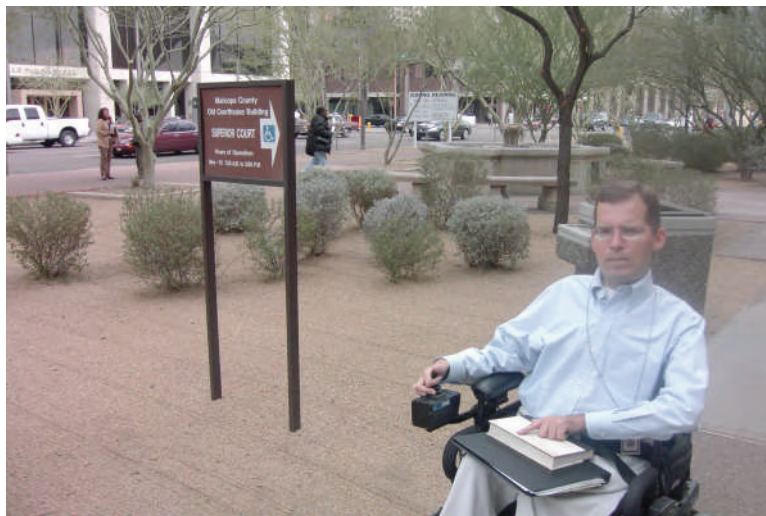
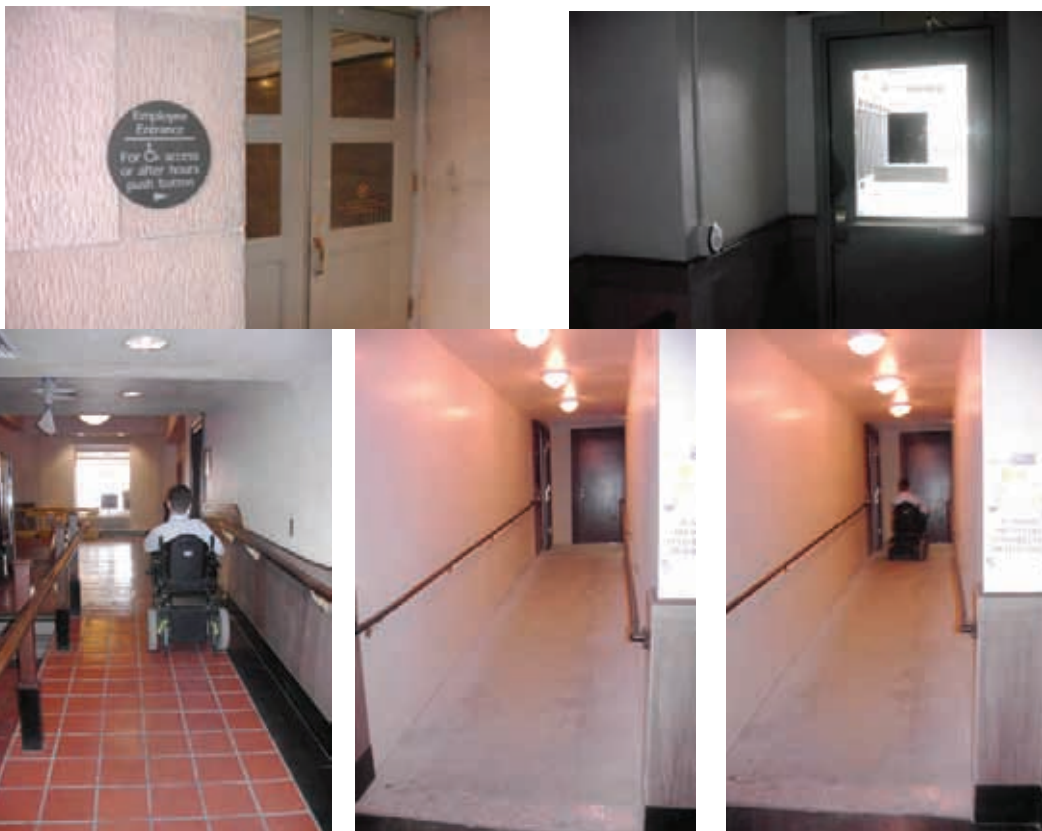
Upon approaching the beautiful old building, good signage directs people to the accessible ramped entrance. Once inside, there is a ramp from lower ground level to first floor and the elevators.

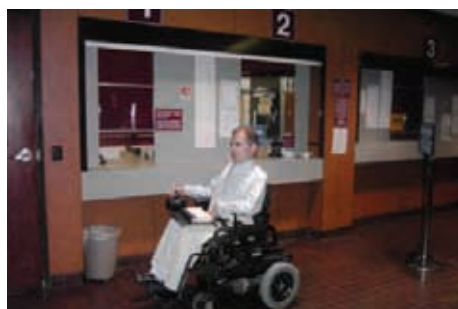
At the main filing counter (non-family court counter) it was noted that there is no "cutout" to enable a person using a wheelchair to fully approach the counter.

Suggestion: It is recommended that at least one counter window has a space cut out so someone using a wheelchair can approach "head on."

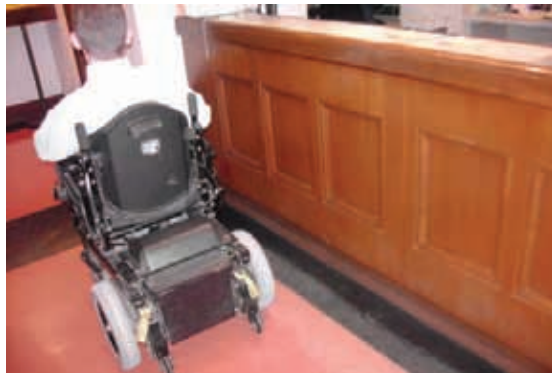
The Counter height is relatively high and inaccessible.

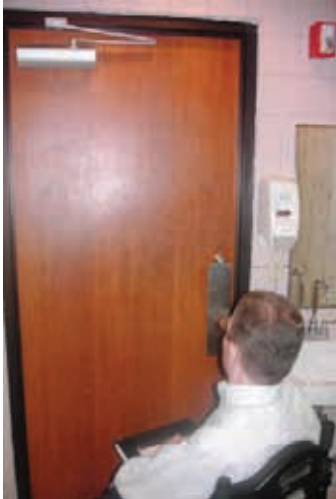
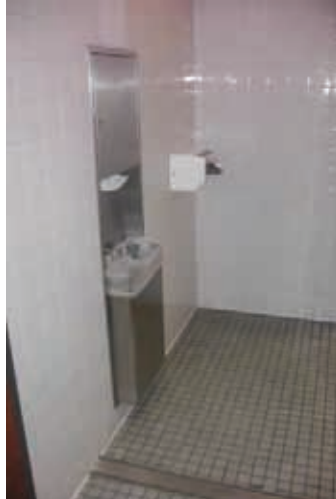
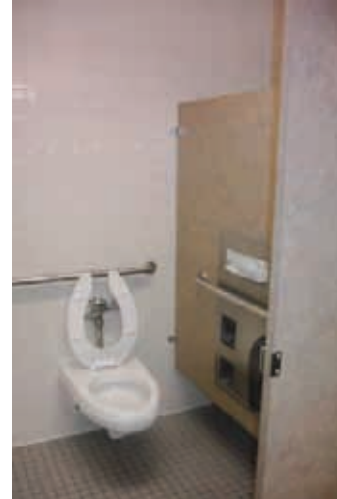
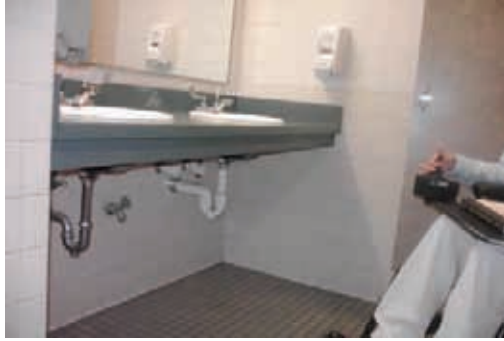
The bathroom nearest the jury assembly area is accessible. However, one must go through an "obstacle course" to reach the bathroom. There is a set of more accessible bathrooms near the elevator banks in the central court building.

Suggestion: It is recommended that signs be posted near the jury bathrooms directing people to the more accessible bathrooms.

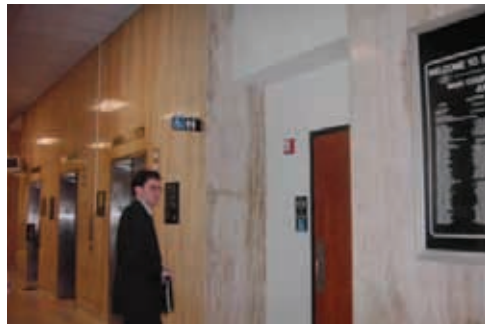
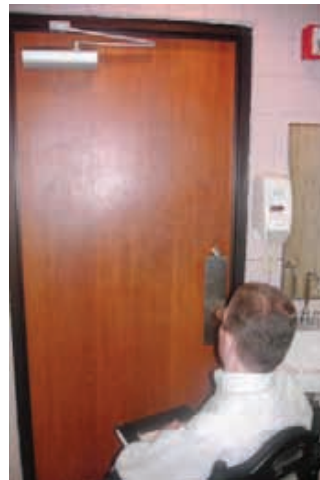
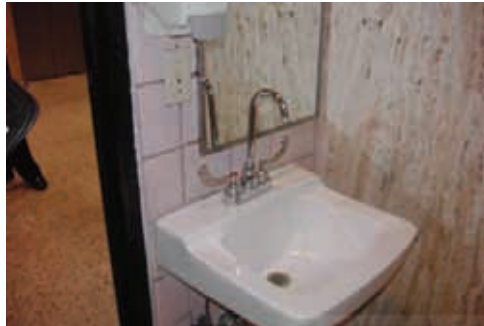
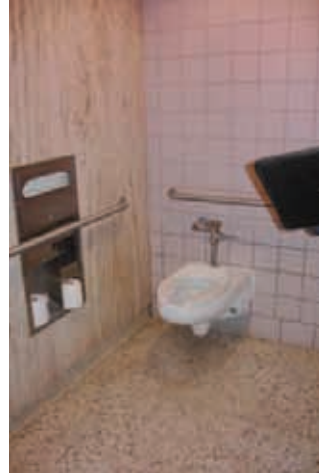
There is a unisex bathroom in the east building lobby near the elevator bank. The bathroom is one small room with a raised toilet and a sink with winged faucet handles. A unisex, accessible bathroom is a wonderful facility that will be useful to many people. This bathroom has the potential to be a model for accessible bathrooms. There is good signage outside the bathroom. The door has less than five pounds of resistance. There is a manual lock on the door. Unfortunately, the lock is mounted rather high and has a very small latch which some might find difficult to grip.

Suggestion: For this bathroom to become universally accessible, we recommend an automatic door opener. The drain pipes under the sink need to be insulated. The manual lock should be replaced with an electro-magnetic lock that can be operated from the inside by a push pad. To see an example, Arizona State University has several electro-magnetic locks installed in unisex bathrooms around its main campus. Additional signage throughout the other court buildings should direct people to this fantastic bathroom.

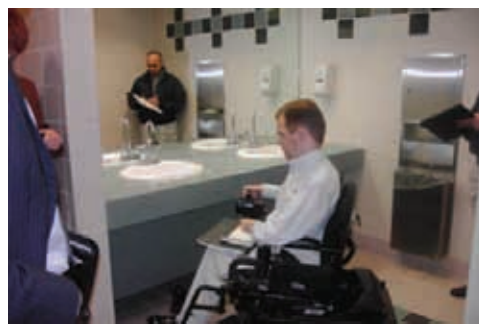
The sinks have winged faucet handles which is good because it makes it very easy to turn the water on and off. However, it was difficult for a person using a wheelchair to reach the sinks because the counter extended too far out. In other words, the sink was installed too far back.

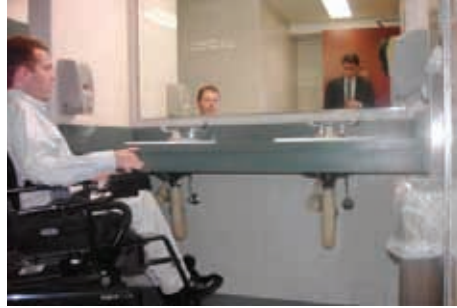
It appeared that some restrooms on this floor have been remodeled; some have not. We recommend posting signs at less accessible bathrooms that will direct people to the more accessible bathrooms.

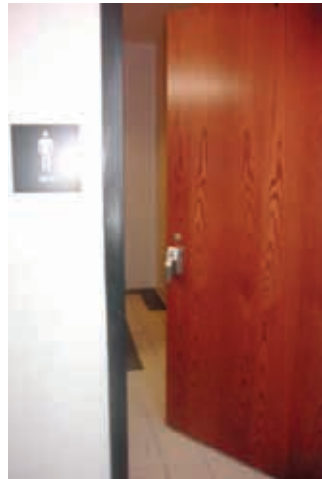
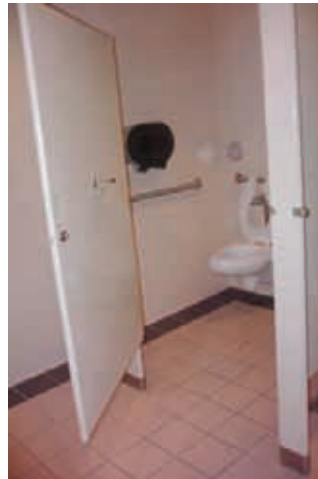
The door "knob" on the restrooms is a latch. This makes it difficult for someone with a mobility disability to open the door. Any time there is a latch or a knob to turn it adds another step to the door opening process. We recommend that all bathroom doors swing freely and not latch or require turning a knob.

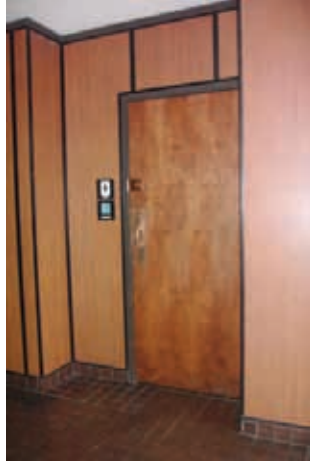
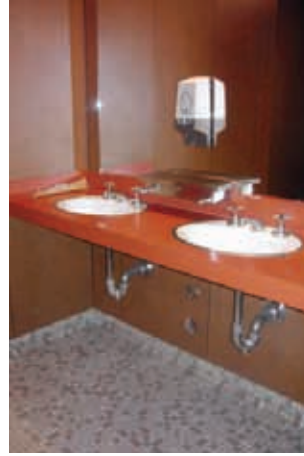
Also in the restrooms, the towel and soap dispensers should be lowered. The faucets in these bathrooms have a "push type" lever. In other words, to turn on the water, the user must push down on the handle. The faucet runs for several seconds, and then shuts off. This is a great way to conserve water, but these types of faucets are difficult to operate. We recommend at least one sink in every bathroom have wing handles which are easier to operate.

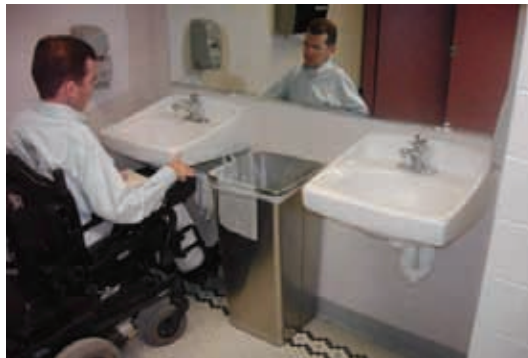
The main floor of the Old Courthouse is being remodeled and has the best sinks in all of the complex's restrooms. Suggestion: As long as remodeling is in progress, we recommend improving this bathroom further by adding push buttons to open/close the door. Signage throughout the building could direct people to this "model" bathroom.

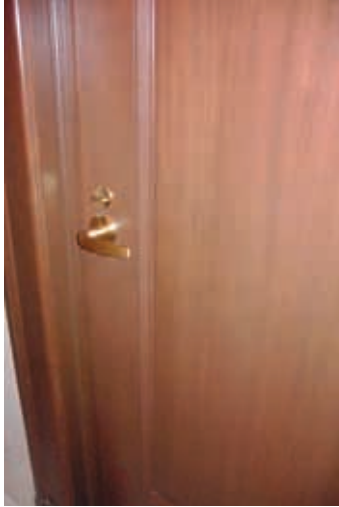
The public restroom on this floor has been remodeled. Unfortunately, the new bathrooms have door latches. As explained earlier, this makes it difficult for a person with limited or restricted upper body mobility to open the doors.

Suggestion: Replace latches with more accessible handles and adjust tension.

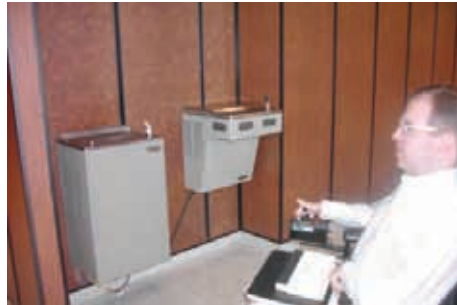
The water fountains in hallways are improperly mounted. The "accessible" water fountain (it has a push bar) is mounted high on the wall. The "inaccessible" fountain is mounted low on the wall, but is impossible for a person using a wheelchair to use because of the fountain's inherent design.

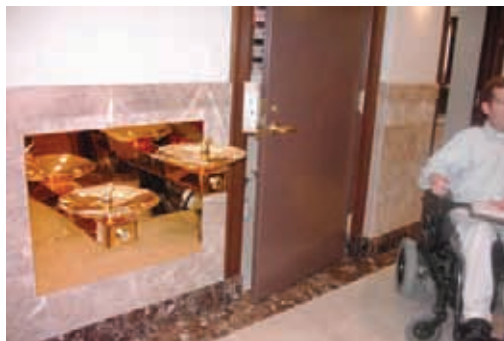
These are accessible.

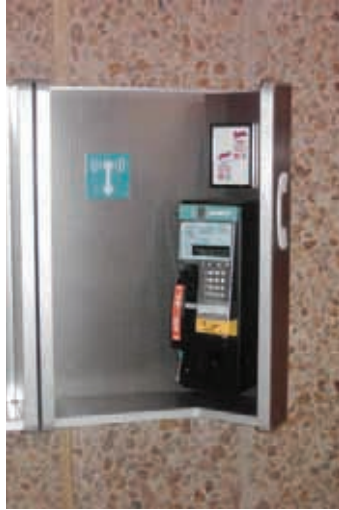
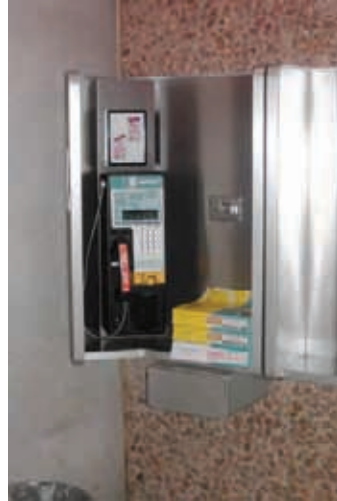
The main public telephone bank in the West Building has a phone that allows the volume to be adjusted. This is denoted with a blue sign.

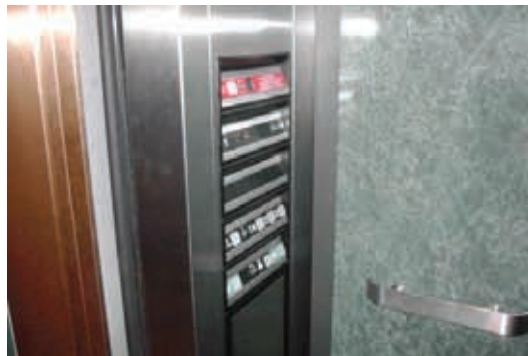
Lower buttons in the elevators were noted.

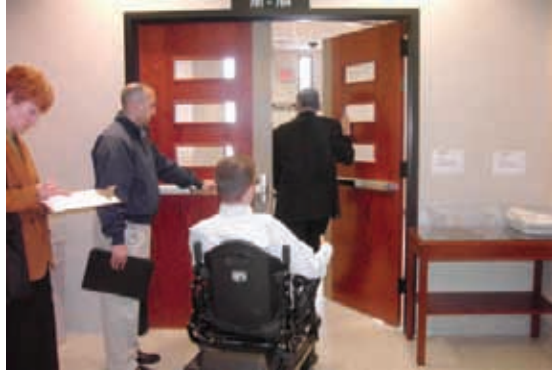
The main double doors accessing many of the courtrooms from the elevator lobbies were quite difficult to open.

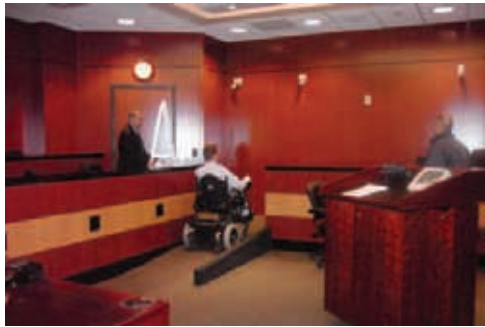
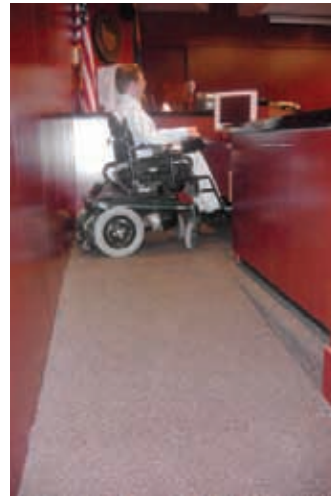
The remodeled courtrooms all have a ramp to the jury box and witness stand. The ramp is fixed in place and does not need to be folded out. The ramps themselves are quite accessible, but once a person using a wheelchair reaches the witness stand, the turnaround and maneuvering area is very limited. For people using large wheelchairs or scooters, the space is not sufficient.

Suggestion: These challenges can be easily addressed on any new renovations or new construction. Simply add more room.

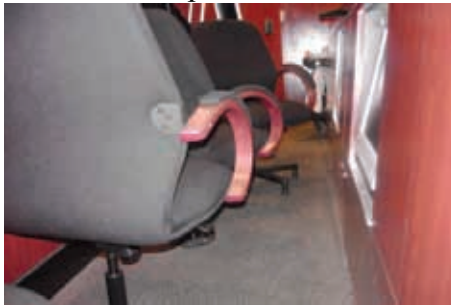
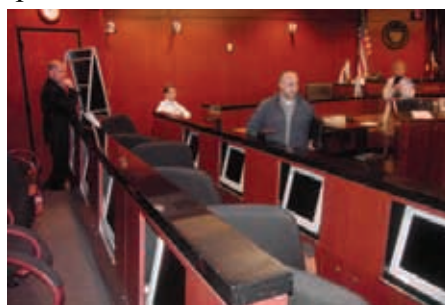
The same problem exists with regard to entering the jury box. There is not enough room to turn once a wheelchair enters the jury box. This could limit a juror's ability to see everything in the courtroom. These doors have crash bars. They may be doors required by fire codes, but we are not sure. We recommend investigating whether the doors can be left open or if automatic door openers can be installed.

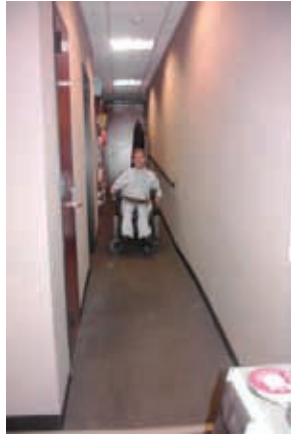
The courtrooms on the fifth floor are typical examples of non-remodeled courtrooms. They were constructed around 1975. There is no accessibility to witness stands or jury boxes. A witness using a wheelchair would have to sit in the well and testify. A juror using a wheelchair could not sit in the jury box.

The door leading from the hallway to the courtroom was quite narrow and challenging for a person using a wheelchair to negotiate.

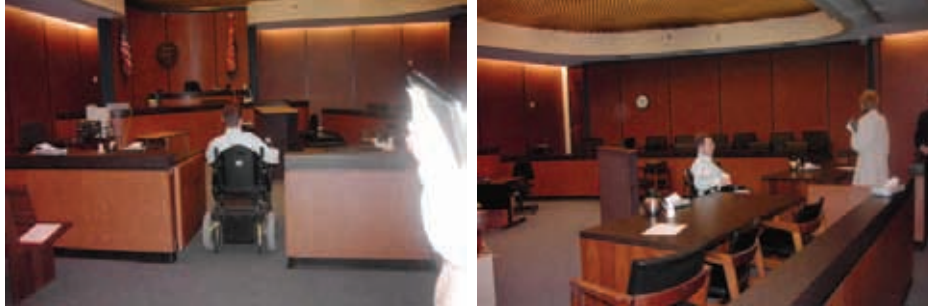
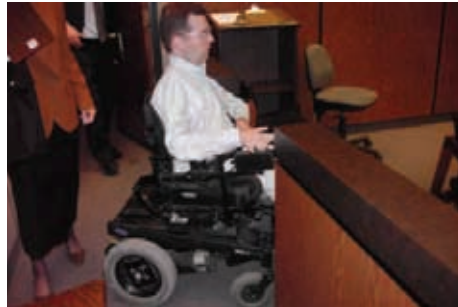
Many accessibility issues in the fourth floor courtrooms were also found on the seventh floor. The door leading from the lobby to the courtroom has crash bars. This makes them difficult to open. (See fourth floor discussion).

There is very little room in the witness stand. See the discussion of the Fourth Floor Courtrooms.

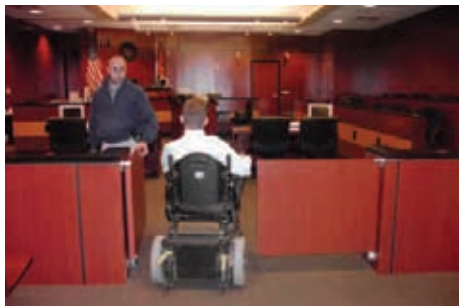
There are no ramps in the courtroom: therefore, no access to the witness stand or jury box. There is no ramp from the judge's chamber to the bench. Overall, these courtrooms are not accessible.

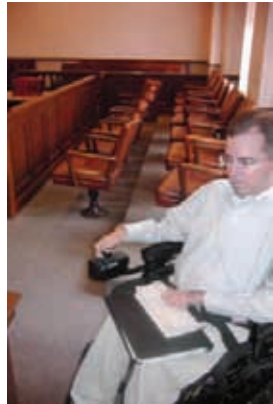
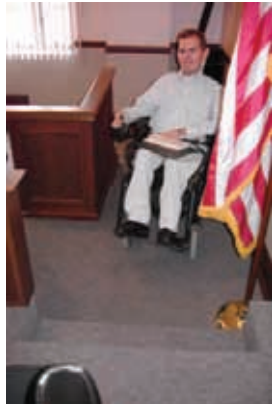
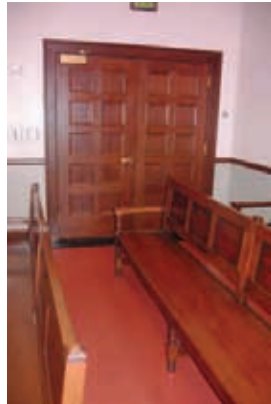
This courtroom is accessible, including the jury box and stand.

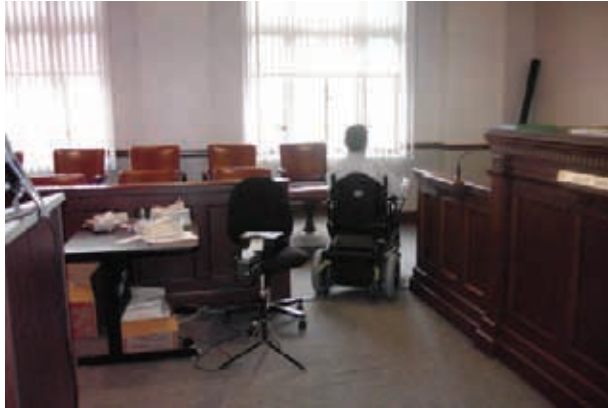
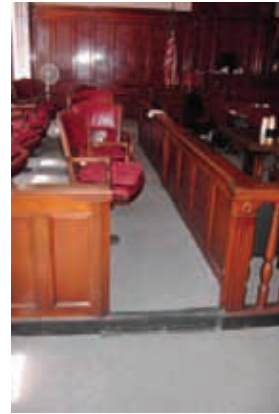
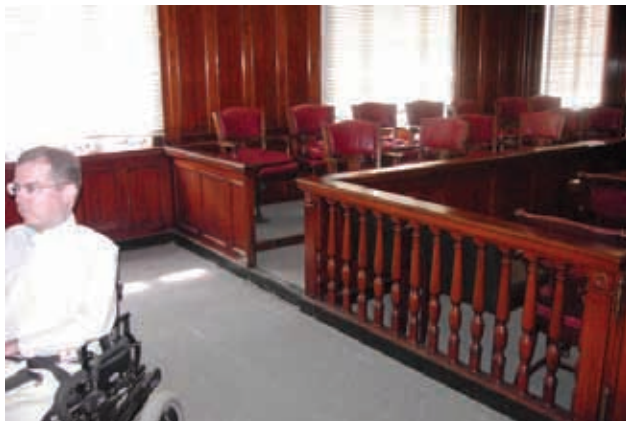
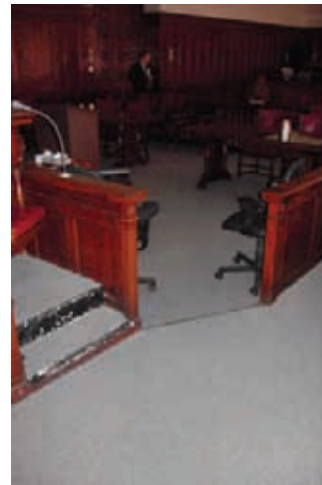
This is a ceremonial courtroom in its original condition. As such, it is not very accessible.

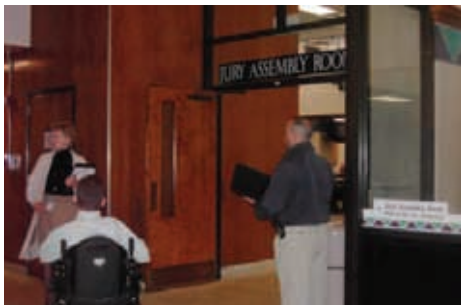
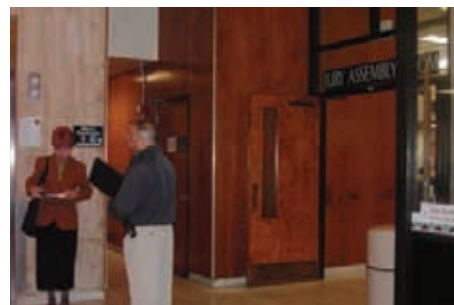
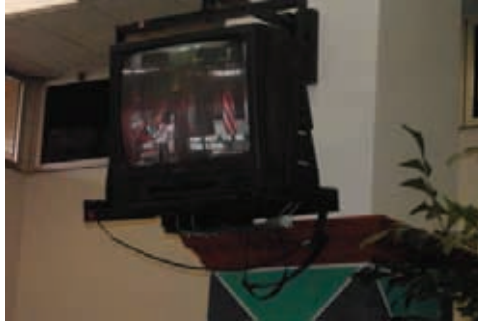
The jury assembly area is located in the West Court building. The area is open and spacious. There is sufficient maneuvering room for persons using a wheelchair. The jury informational video was closed captioned. The TV monitors which show movies, however, are not closed captioned.

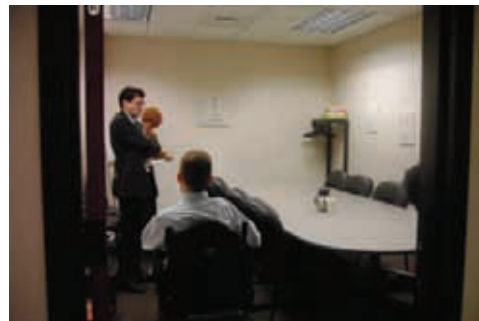
The jury room offered only small, tight quarters. It did not seem very accessible (not even the water fountain).

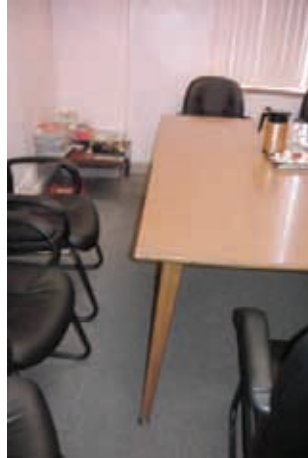
The Jury Room is accessible.

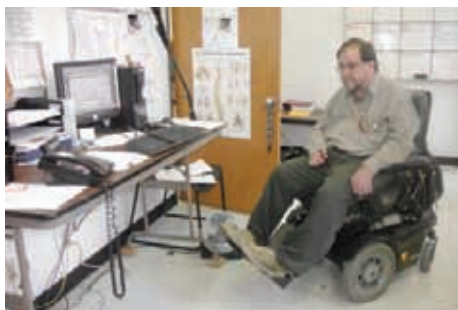
On the second floor, court administration remodeled an office for an employee who uses an electric wheelchair. The area was widened and a second door was installed. Additionally, the employee's work surfaces were raised up to an accessible height.

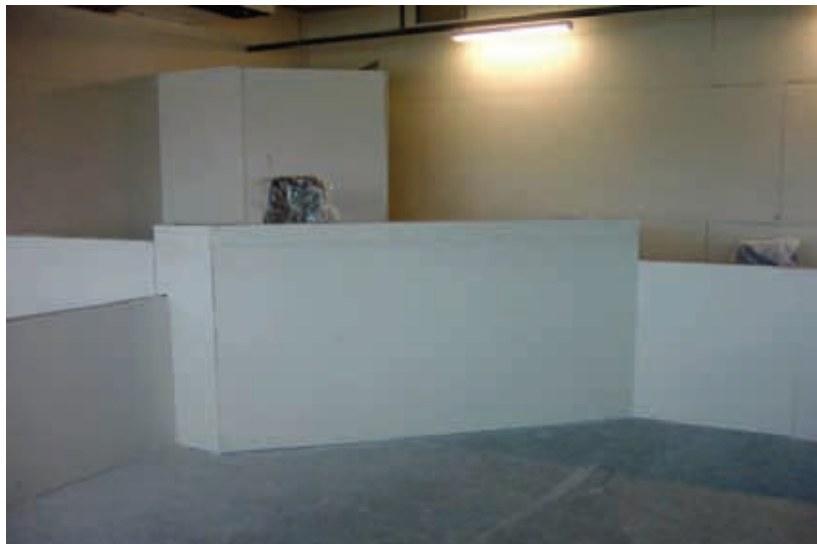
The Bench appears in the right corner of the design courtroom.

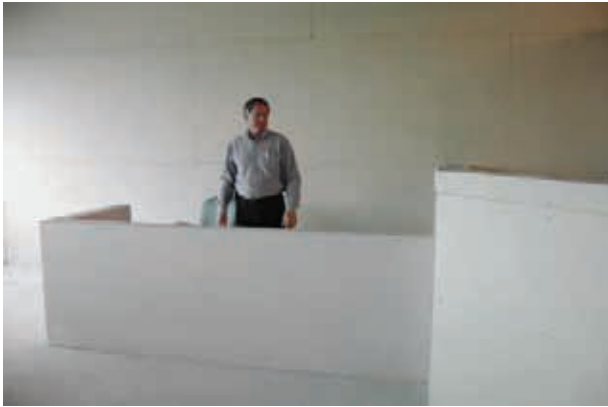
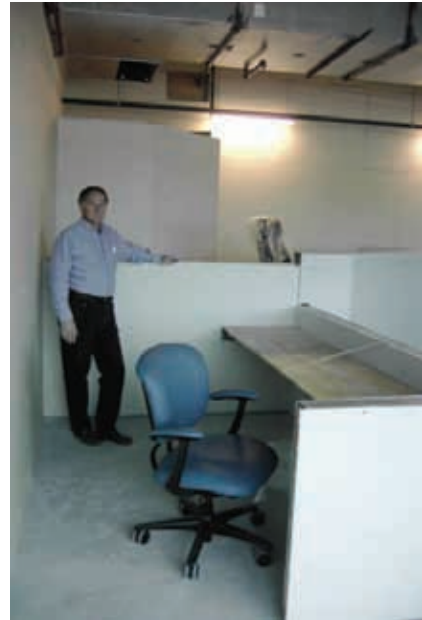
On the left side of the courtroom, to the Judge's right, are the witness stand and then the jury box.

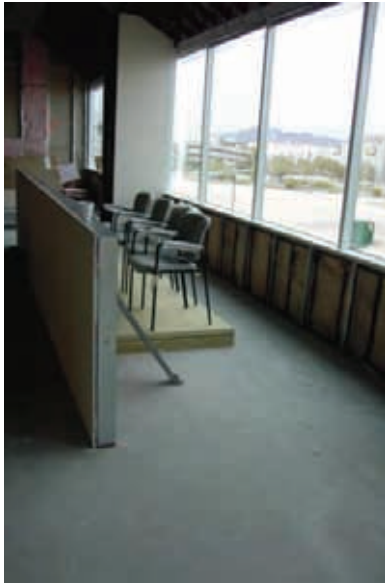
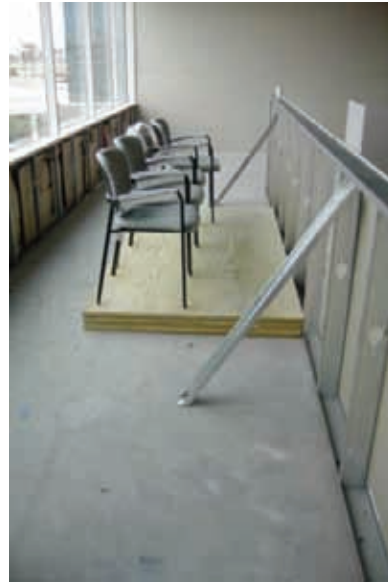
The Jury Box is to the Judge's far right, on the left side of the courtroom and directly opposite and facing the judicial clerk's table.

The Layton Construction courtroom design was accessible, with appropriate access to the witness stand and jury box. It is a design intended for implementation in new Maricopa County Court construction.
