**State Bar of Arizona Task Force on Persons With Disabilities
Accessibility Committee Site Visit
Graham County Superior Court
City of Safford Justice Court
Safford, Arizona**

Facility: Graham County Superior, Safford, Arizona, and the City of Safford Justice Court

Date: May 25, 2004

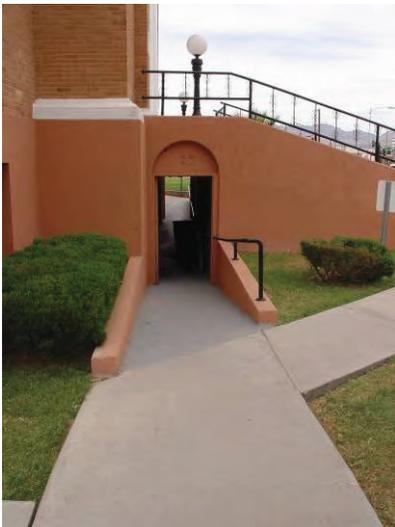
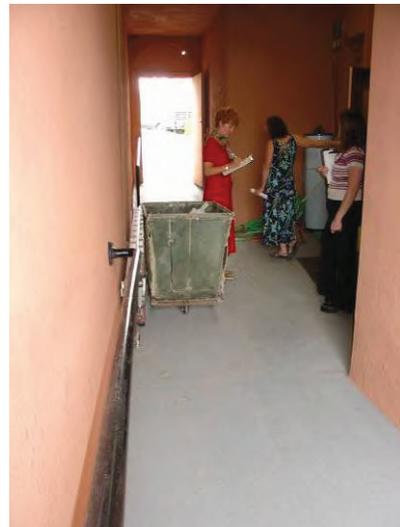
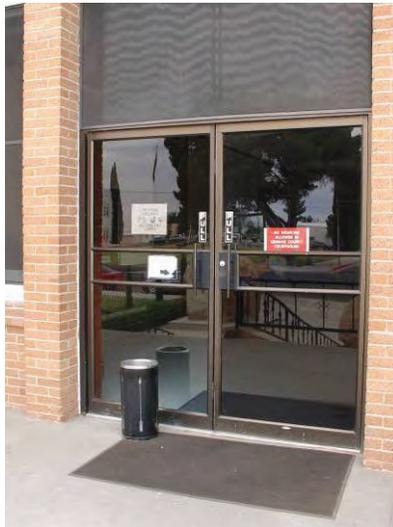
The main accessible entrance was challenging, but functional. The accessible entrance is behind and underneath the main court entryway, and opens into the basement of the building. The accessible entrance is not an automatic door, and also functions as the delivery entrance, which is not uncommon for many of the courthouses visited, or even a criticism; if the entryway can be commercially useful for purposes other than accessibility considerations, then it confirms the wisdom of universal design. While no signage indicated the availability of an accessible entrance, the railings leading down the ramps to an opening underneath the main stairway entry to the court, were clearly visible. On the day we visited, some maintenance and construction materials were in the entry area, but did not appear to present an obstruction to the entryway.

The accessible entrance could be a lighter tension, but was slow-closing, which is helpful for persons with mobility challenges. Light tension doors can be used at entrances, without the door being subject to wind or air pressure pulling it open.

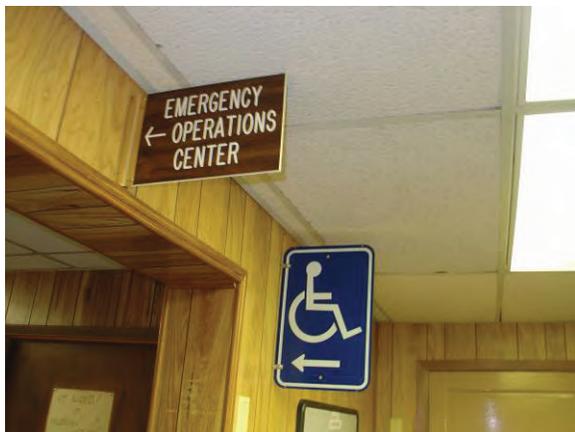
There were no evacuation maps or procedures posted, but a sign indicated an emergency exit which is accessible. Administrative staff would assist members of the public, including persons with disabilities, during any evacuations. The fire alarm handles seemed somewhat high for a smaller individual or someone using a wheelchair or walker. There is no Braille associated with the fire alarms or with any emergency exits. Persons with disabilities would be very dependent on courthouse staff in the event of emergency, who appear helpful and available.

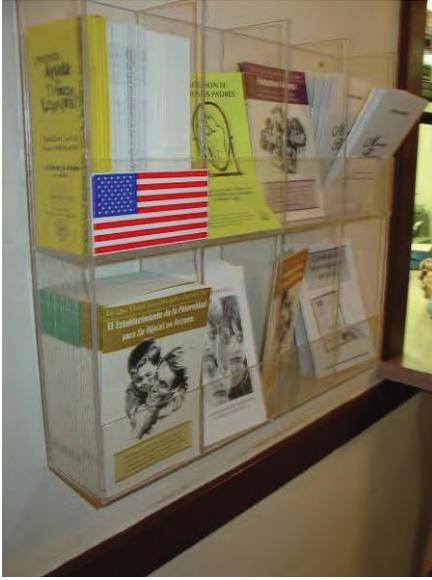
While the informational bulletin shelf at the entrance to the Courthouse was outstanding, there is no pamphlet currently available describing services for persons with disabilities. However, this was consistent with most of the courthouses surveyed in Arizona.

Similarly, and consistent with any budget demands, some consideration could be given to publishing a pamphlet for members of the public or those in the legal profession with disabilities.

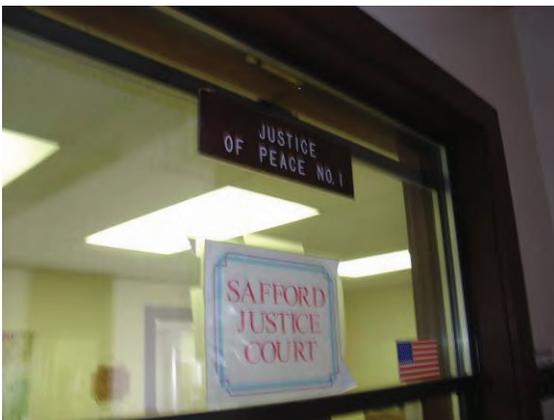
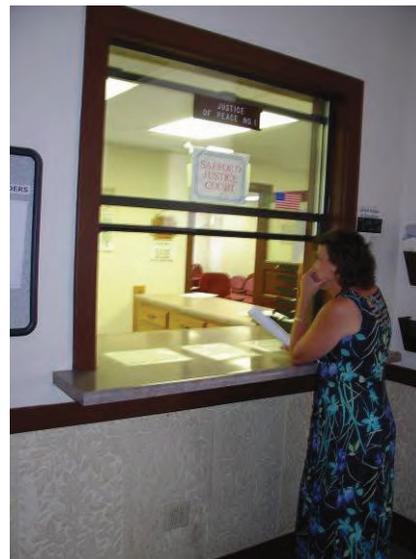
The Safford Justice Court Clerk's window presented access challenges to any person of low height or using a wheelchair.

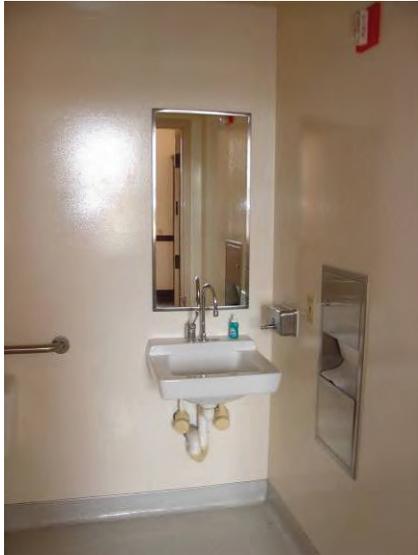
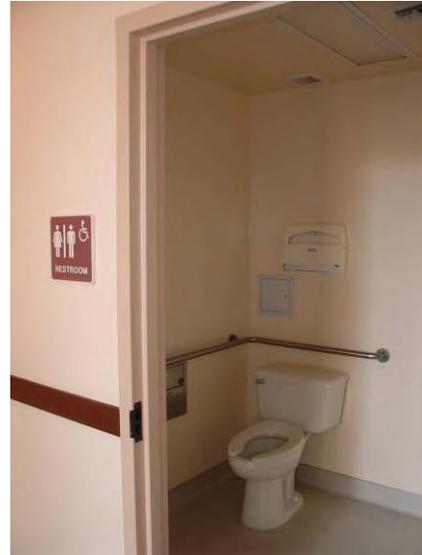
The restrooms were accessible on all floors. All restrooms seemed accessible with no significant issues or concerns noted. The sidewall placement of soap dispensers was optional, mirroring the survey's recommendation for sidewall placement to permit persons in wheelchairs or with low height to reach the dispensers without excess soap materials falling on the floor and creating a slippery surface. The lower level bathroom did not have a heat-protection pipe wrap.

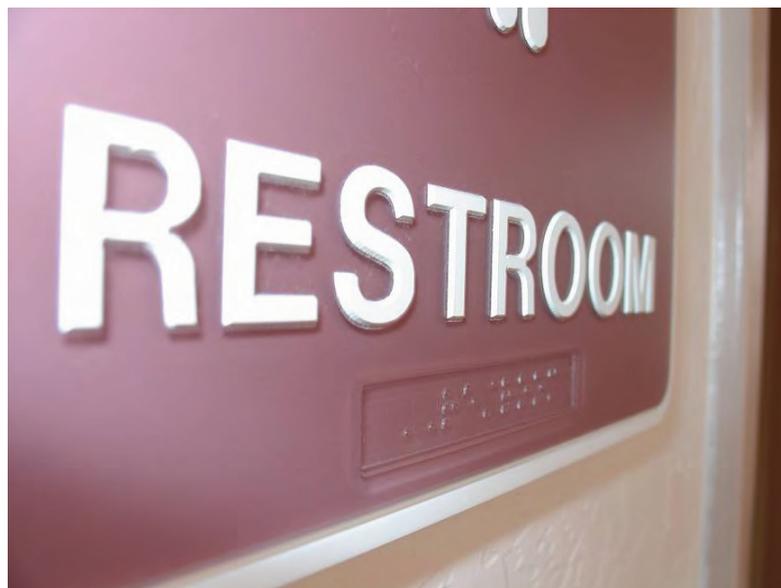
The third floor has a unisex bathroom, but with Braille description. Braille identified all of the bathrooms in the building. That bathroom was fully accessible, including wheelchair entry and exit space, heat wraps on the sink pipes, and a soap dispenser to the sidewall, making it easier to reach.

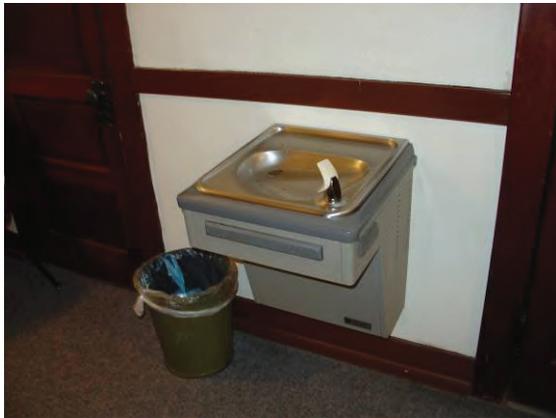
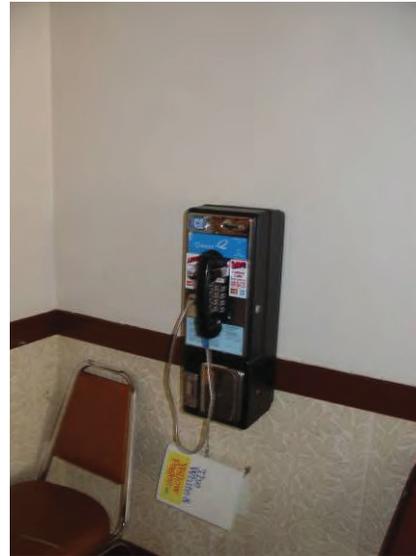
All hallways were wide.

Each floor that the team observed had a water fountain at wheelchair height, and all were functional.

The public telephone was placed at an accessible height, with TTY capacity.

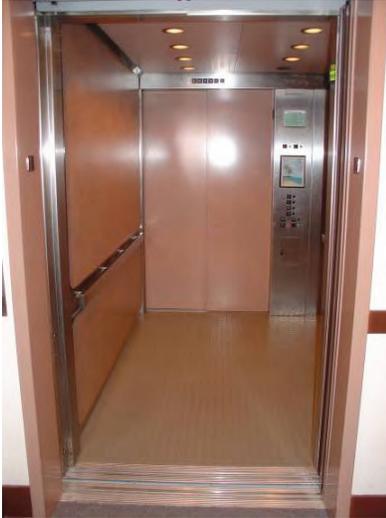
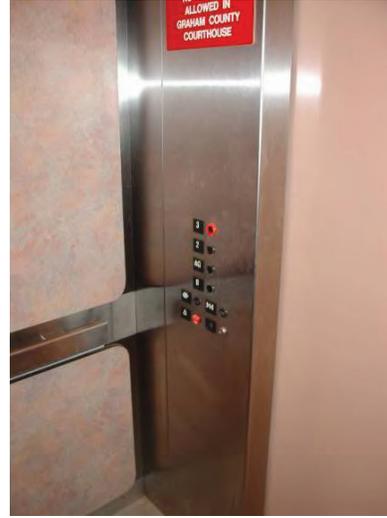
The public elevator is large, with a railing inside. There was sufficient room in the elevator for entry and mobility, and the elevators had a non-slip, rubber tile surface that was extremely safe and functional. The buttons were placed at appropriate heights. The elevator floor indicators outside the elevator were in Braille.

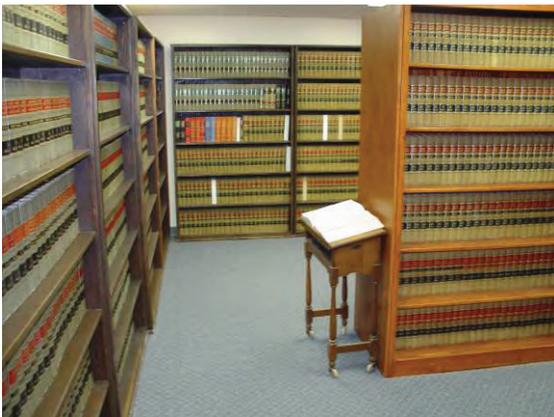
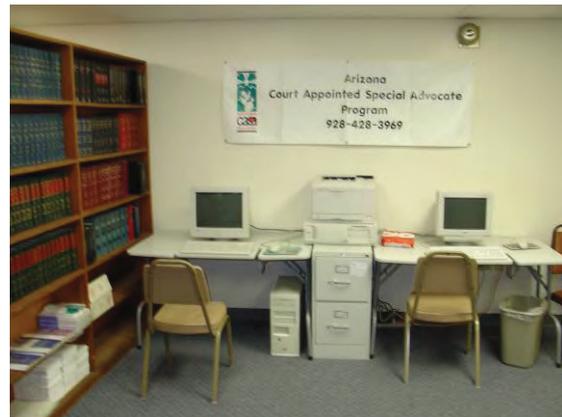
The law library is located on the bottom floor and was quite functional for a person using a wheelchair or generally having mobility challenges. The library is open to both staff and members of the public. The library was moved to the bottom floor because of the heavy weight of the books, reflecting the degree to which the courthouse staff was working with an older structure. It has a fully accessible water fountain at wheelchair height and electronic research facilities. A large banner was prominently displayed in the library for a Court Appointed Special Advocate, with a telephone number, with a scope of assistance that presumably would benefit persons with disabilities.

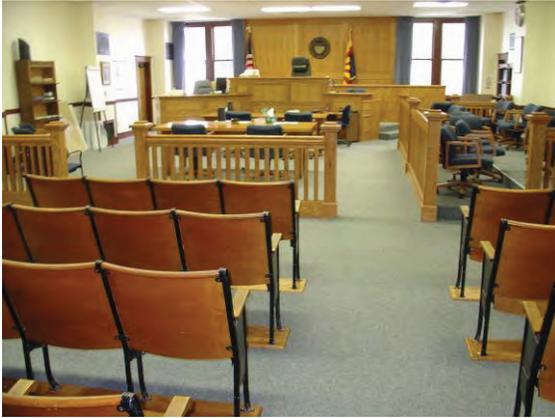
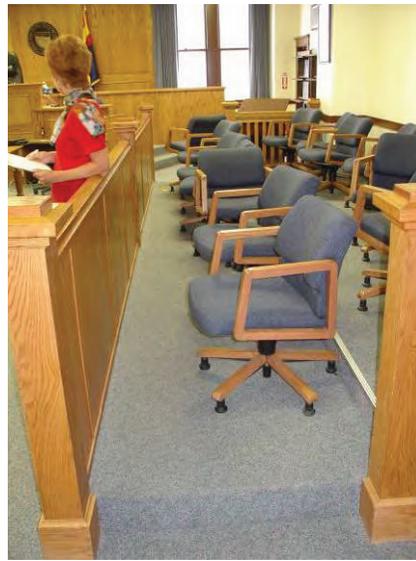
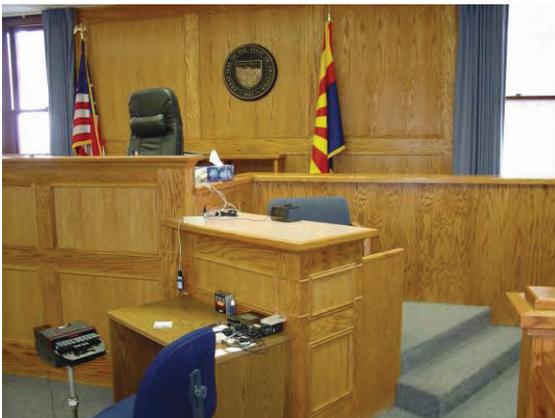
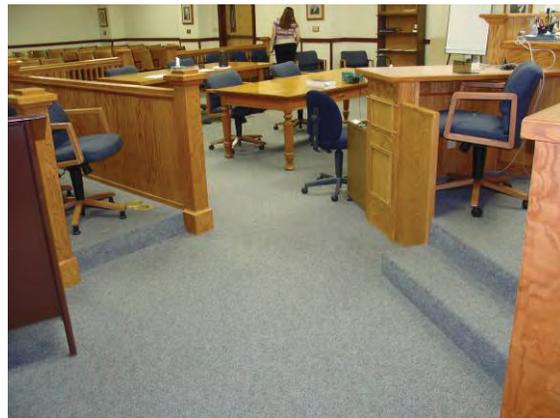
Courtrooms are located on the main and basement floors. The upper level courtroom is partly accessible to members of the judiciary and public, and partly not. There are two steps, without a ramp, leading to the witness stand. There is one step, without a ramp, leading to the first observation tier of the jury box and a second step leading to the second observation tier. There is no gate separating the public gallery from the courtroom well, with two easily-passable entrances. The jury box only has chairs on casters, which may be easily moved to accommodate a juror using a walker or other mobility assistance. There is sufficient room in the gallery for numerous users of wheelchairs to easily move and observe proceedings immediately behind the railings.

The doors in and out of the courtroom, with two entrances for the public, all had crash bars. The main entryway doors were medium tension, but had a post between the two, for both security and noise control purposes. While representing a common courtroom design throughout Arizona, the barrier would present somewhat of an obstruction both for persons using wheelchairs and attorneys moving exhibits in and out of the courtroom. The door tension is initially medium, and increases towards 90 degrees extension. A common experience in reviewing courthouses in Arizona is that any door with a maximum extension of 90 degrees commonly is difficult for even a normal user to pull open past approximately 75 degrees.

The courtroom “well” was large. Castered chairs at the counsel table are easily removed to accommodate a wheelchair. The area behind the counsel table is large and open, permitting wheelchair use if necessary.

The Graham County Courthouse is a generally accessible building, both in its main areas of public use and in its courtrooms. Personnel responsible for administering the facility seemed aware of the needs of persons with disabilities. The historic courtroom presents a challenge for accessible use, with the simplest suggestion being a removable ramp to the witness and jury boxes.

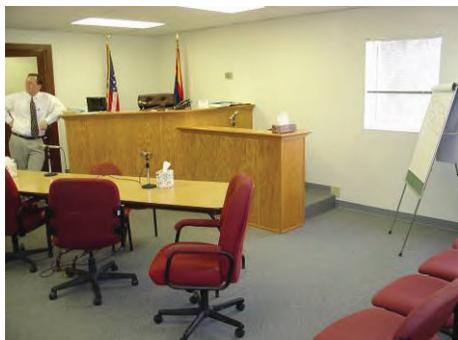
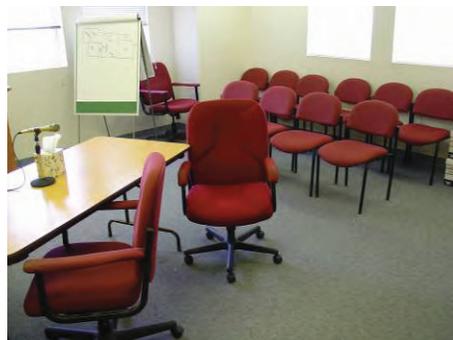
The Justice Court Courtroom was essentially accessible, once again demonstrating that the more basic the courtroom elements, the more accessible the facility generally is. There was no jury box, with four rows of ordinary chairs supplying that instead, any of which could be removed or moved to accommodate a person with a mobility disability or using a wheelchair. The same is true for the table and chairs constituting counsel’s table. The witness stand had one step.

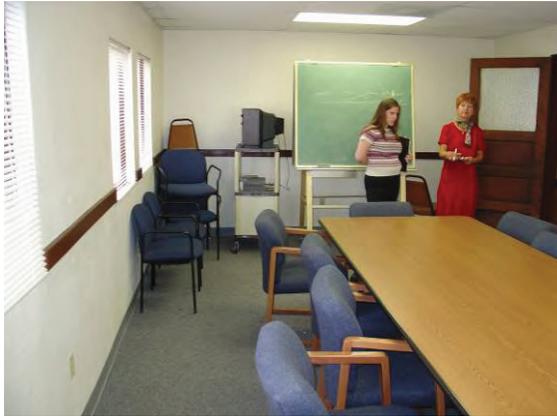
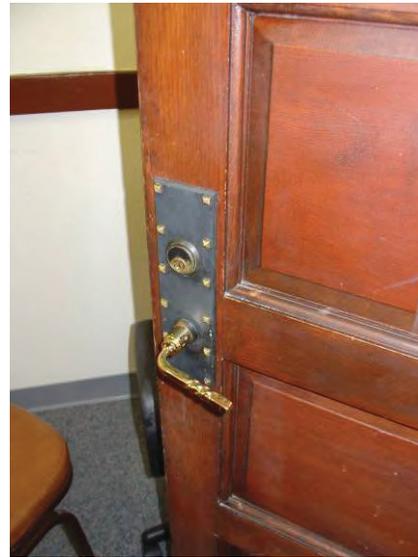
The jury deliberation room on the upper level Courtroom floor was somewhat small, but did appear accessible in all material respects. The jury deliberation room doors have ornate, but accessible “wing” or latch handles.
