**State Bar of Arizona Committee on Persons With Disabilities
Accessibility Committee Site Visit
Apache County Superior Court
St. Johns Justice Court
St. Johns, Arizona**

SURVEY BACKGROUND

Facility: Apache County Superior Court and St. Johns Justice Court, 70 West 3rd South, St. Johns, Arizona 85936

Date: Tuesday, April 27, 2004

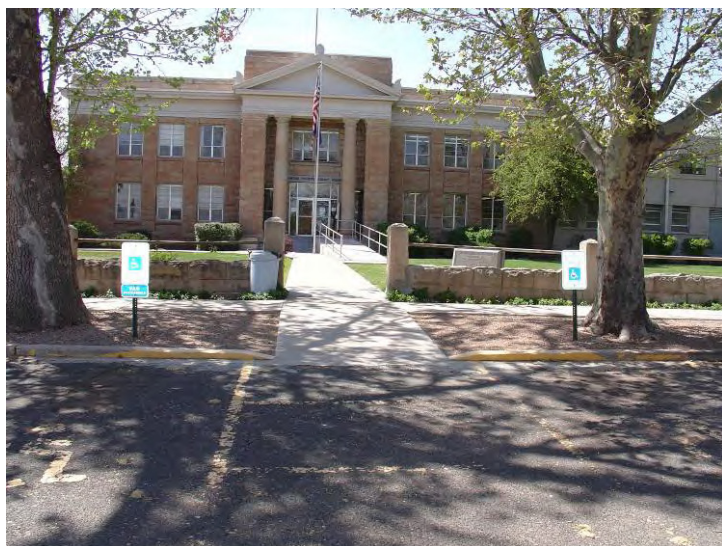
The public parking lot is located at the front of the building. Several accessible spaces are clearly marked.

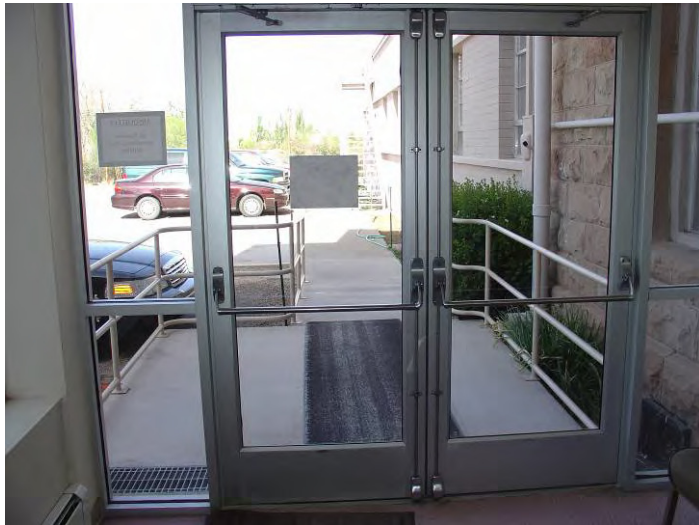
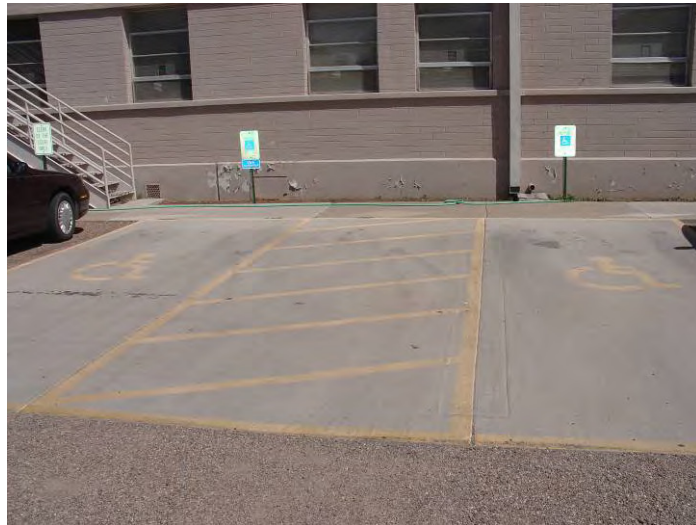
There is an exit, via a ramp, at the back of the building which leads to the employee parking lot. A security card is required to access this entrance from the lot. Accessible parking is available and spaces are wide.

If the elevator were to be turned off in the event of an emergency, the only exit from the second floor is by way of the stairs.

Suggestion: An adjustment to the tension of the front door is the easiest and least costly modification that can be made to enhance access. In addition, a doorbell and signage could be installed at the front entrance which, when rung, could alert courthouse personnel that an individual required assistance.

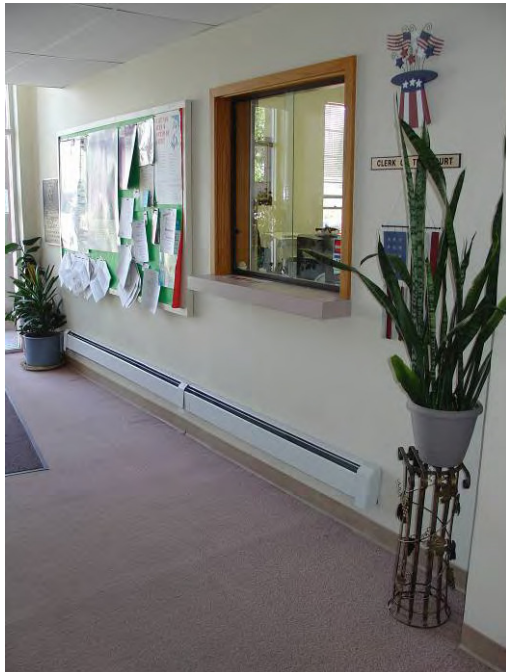
The filing counter in the hallway (inside the main entrance) was built to accommodate/serve one individual at a time. It appeared to be approximately 40 inches high.

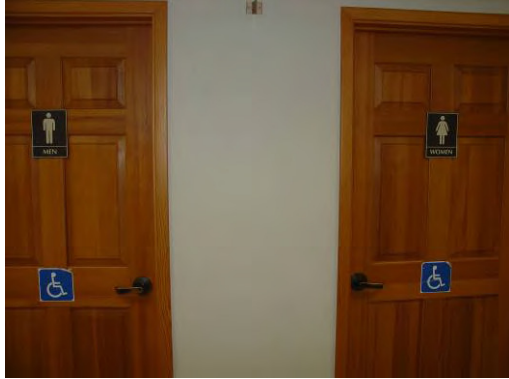
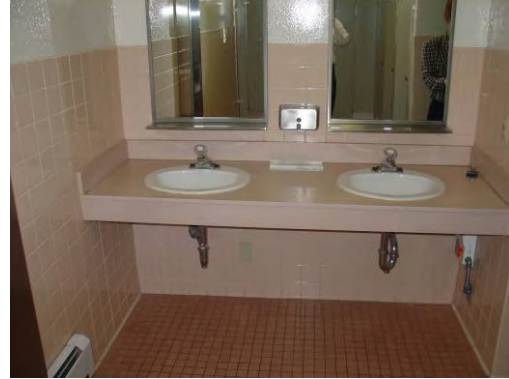
The restrooms were accessible.

Suggestion: Reposition the soap dispensers at the sides of the sinks for easier access. One has to reach across the counter to access them; difficult for someone using a wheelchair. Wrapping the pipes beneath the sink would protect persons using a wheelchair from possible burns.

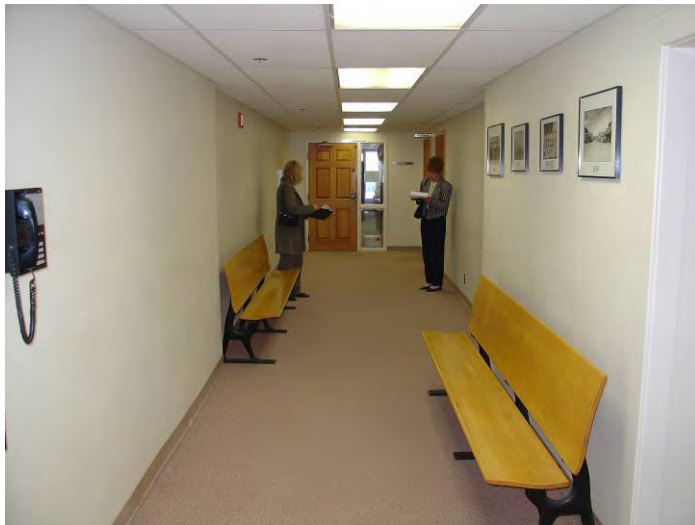
The hallways were accessible even with benches and seating placed along the wall for visitors to the courthouse. Latch-type door handles, which are easy to open, are utilized throughout the facility.

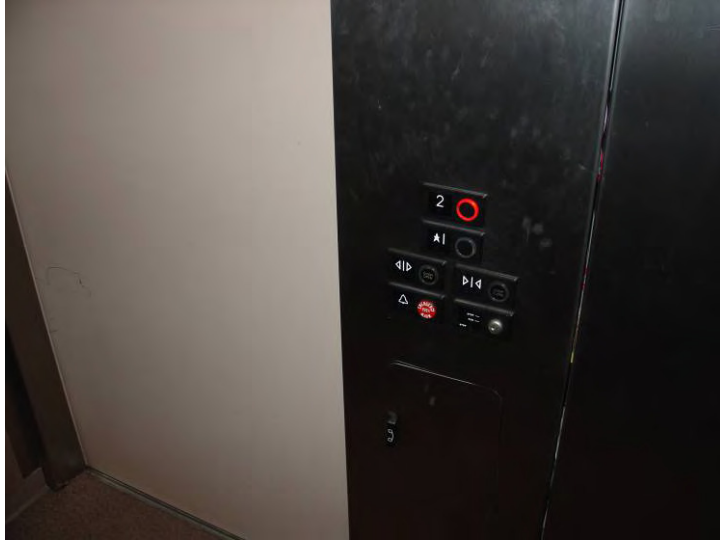
The elevator was installed in 1993. Due to its specific placement and construction issues relating to this historic building, a ramp to the elevator was constructed in order for it to be totally accessible. The elevator is large enough to hold several individuals including a person using a wheelchair. For individuals with vision limitations, there are audible “dings” that indicate on which floor one has arrived. Braille signage is posted.

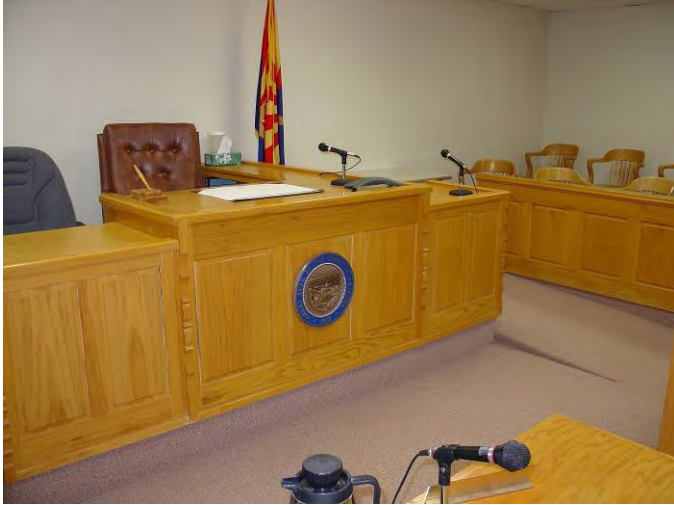
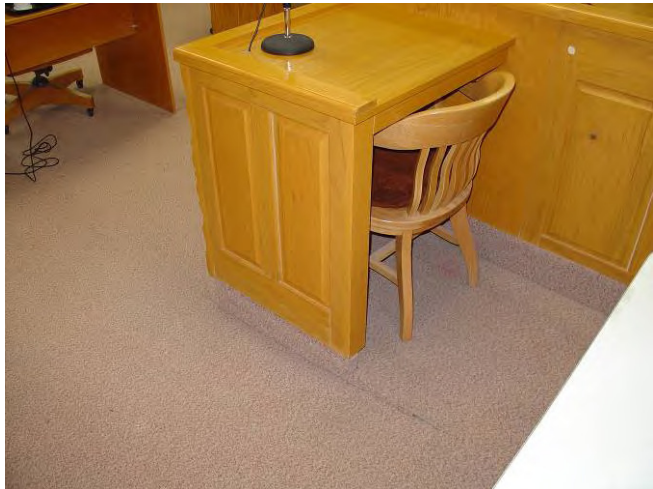
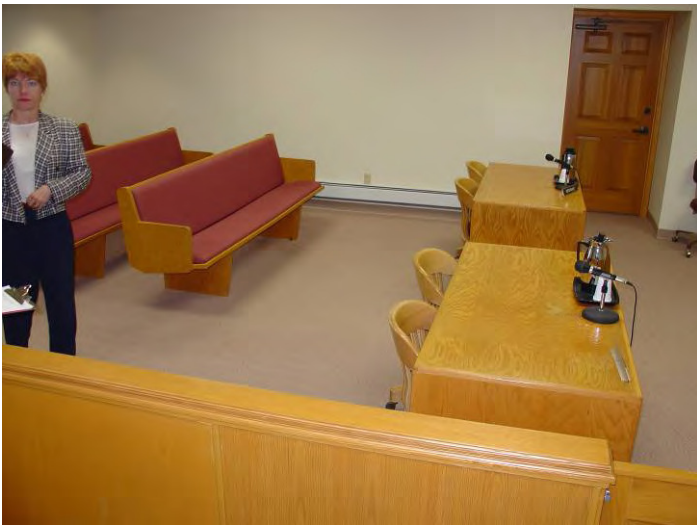
The Justice Court courtroom is simply outstanding. One bench had been removed from the gallery to accommodate persons utilizing mobility assistive devices. There is a ramp to the jury box and to the witness stand. This is a perfect example of the effective construction and use of ramps in the courtroom – a model that could easily and relatively inexpensively be replicated in courtrooms across the country.

One chair at the end of the jury box by the ramp is removable to accommodate a person using a wheelchair or scooter. If a defendant or juror does not sign, the court staff arranges for a real-time court reporter to travel in from Flagstaff (149 miles away).

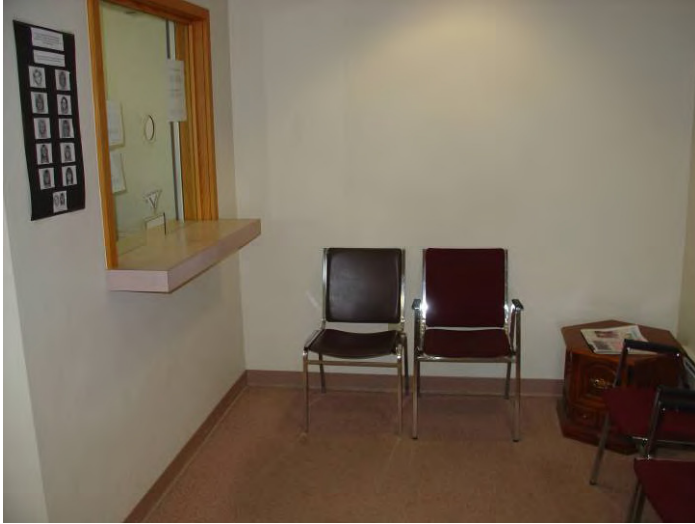
Comparable to the one on the first floor, the counter was built to accommodate/serve one individual at a time. It appeared to be approximately 40 inches high.

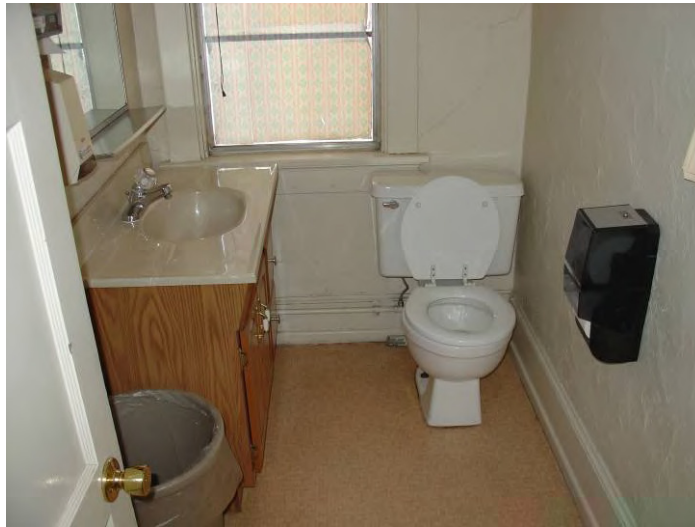
The restrooms are accessible although smaller than those on the first floor.

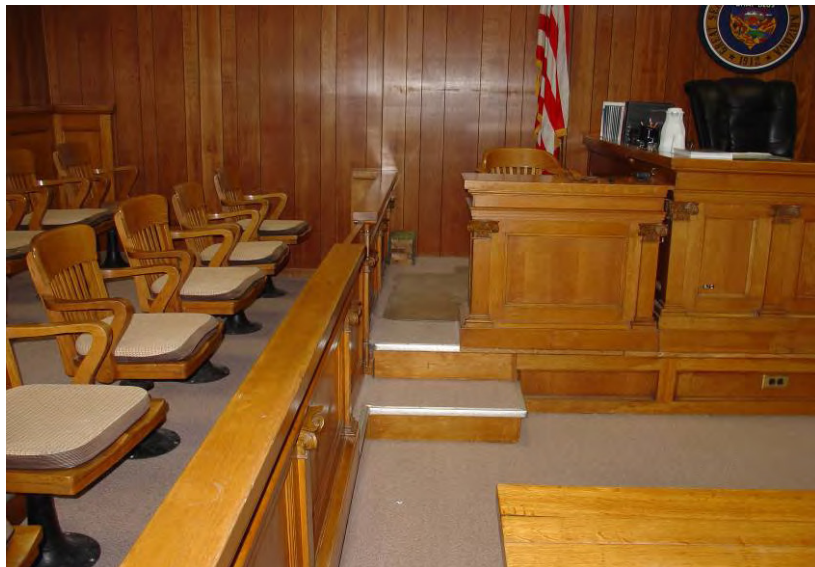
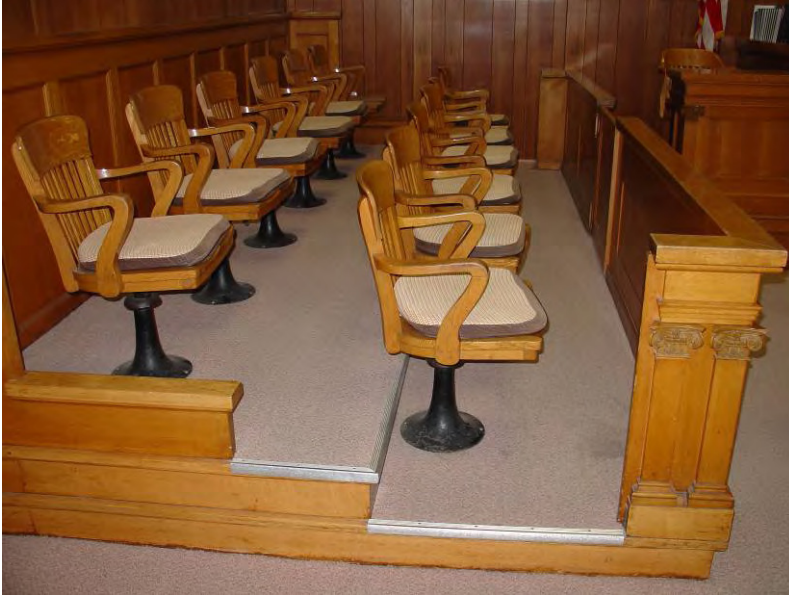
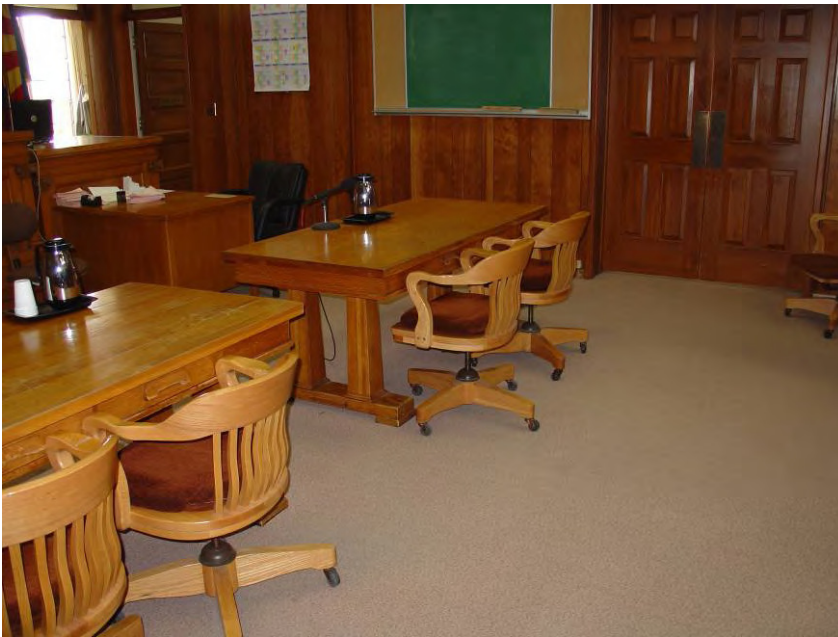
The tension on the door to the courtroom is appropriate. Upon entering, one is transported back in time to 1917. Many of the fixtures and furnishings are original pieces. Due to its historical registry designation, there is reluctance to remodel or make modifications to the courtroom. That does present some challenges for individuals with disabilities.

There is a step up to both the jury box and the witness stand. This is a very large room with a high ceiling and wooden floors and, therefore, the acoustics are less than desirable. The court does not have assistive listening devices.

Suggestion: It would be possible to lower the witness stand to floor level. The Justice Court on the first floor has a ramp to the jury box and to the witness stand, and this could be replicated here. Due to space limitations, a piece of the jury box railing could be cut and hinges installed so that a section of the railing swung out to accommodate a juror using a wheelchair in order to navigate the proposed ramp. Interpreters would be made available if requested.
