**State Bar of Arizona Committee on Persons with Disabilities
Accessibility Committee Site Visit
Gila County Courthouse
Arizona Superior Court in Gila County
Globe, Arizona**

Facility: Gila County Courthouse, 1400 E. Ash, Globe, AZ 85501

Date: May 7, 2004

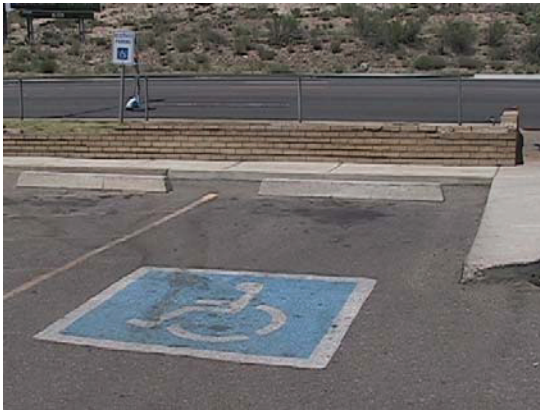
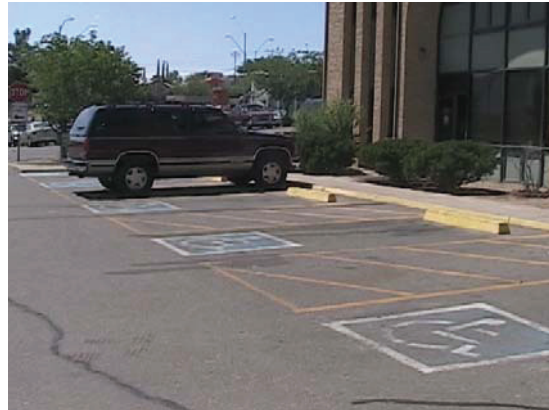
There is ample parking for the persons with disabilities at the back entrance, and this parking is located next to the entrance with a ramp. There are also two accessible spaces in the front of the building.

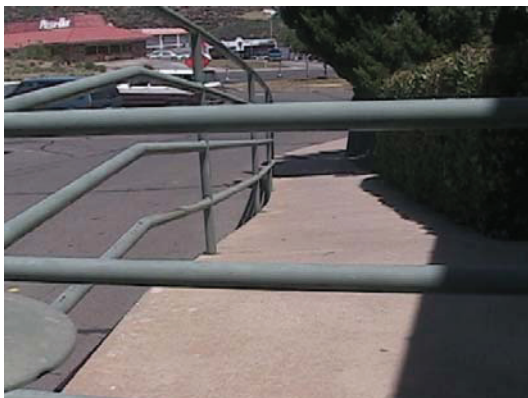
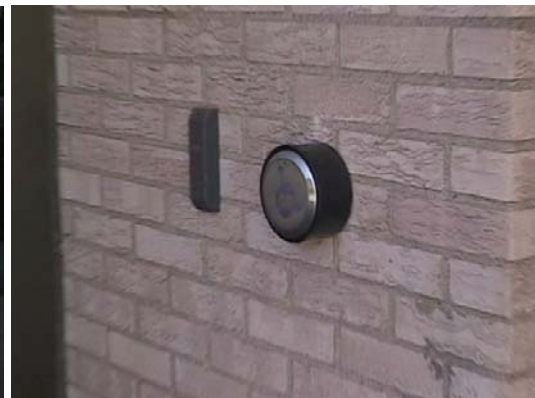
The major entrance for persons with disabilities is in the back. It has a good ramp leading to it and the parking is located next to the ramp. There are signs outside the front and back of the building indicating that the doors to the inside have push buttons. These buttons were round, rather than square, so there is no chance of snagging clothing on them. In addition, the doors are slow to close, which provides for safety.

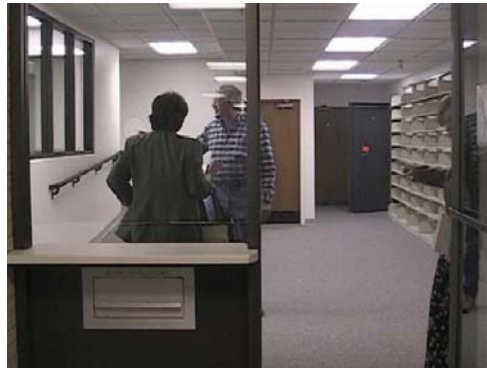
The counter in the justice court clerk’s office is high. Mr. Hickman suggested that the counter for one window could be lowered when the budget permits such a modification. Counters to the clerk's office were accessible.

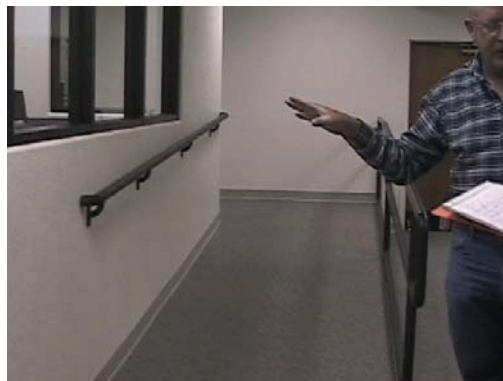
There is a ramp leading to the court reporter's offices.

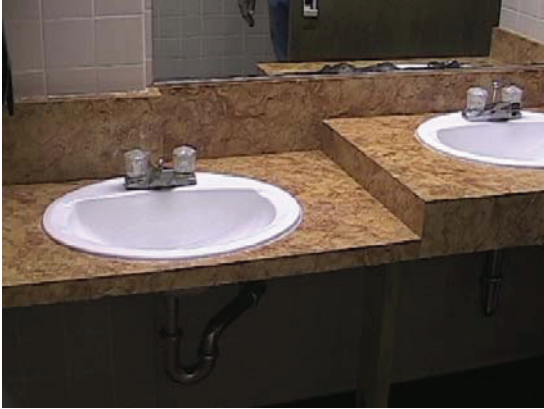
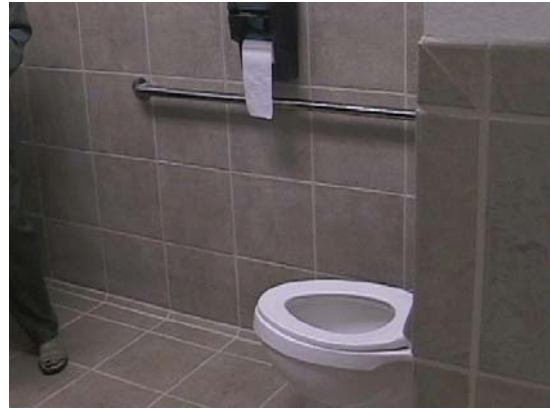
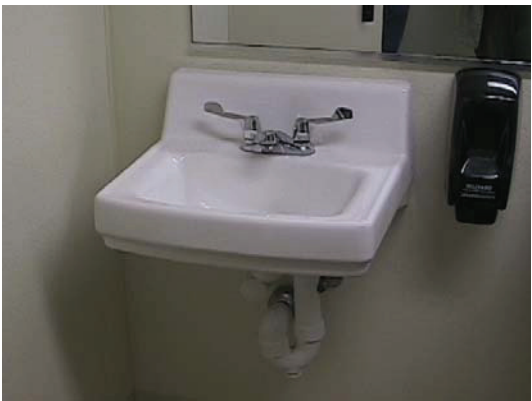
The second floor restrooms, while not fully accessible, have been improved to accommodate some individuals with disabilities. A portion of the counter and a sink have been lowered to better accommodate persons using a wheelchair. Soap dispensers and paper towels are also within easy reach. Each has a larger stall, which accommodates a person using a wheelchair, scooter or walker.

Suggestions: Since fully accessible restrooms are located on the first floor, we recommend that signs be posted on or near the second floor bathroom doors to direct those needing fully accessible restrooms to those on the first floor.

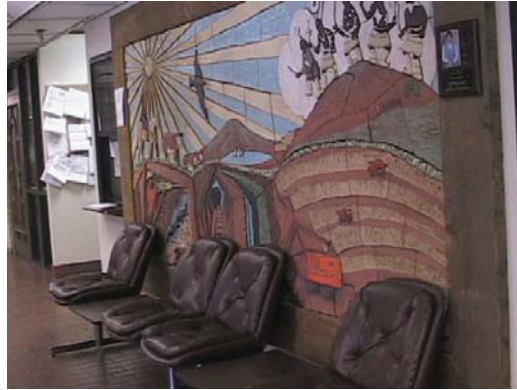
Almost all hallways were wide and would be very easy to negotiate, even for an individual using a wheelchair. The telephones are at a good height and have TTY capacity. However, the phone on the first floor is located between two vending machines. At least one vending machine could be moved a foot or two and allow easier access to the phone.

Drinking fountains were at accessible heights. Even the fire extinguisher was located at an accessible height.

There was plenty of seating in the hallways and lobby for those who might need to rest. Door handles were pull handles, but the doors were not too heavy to be an impediment.

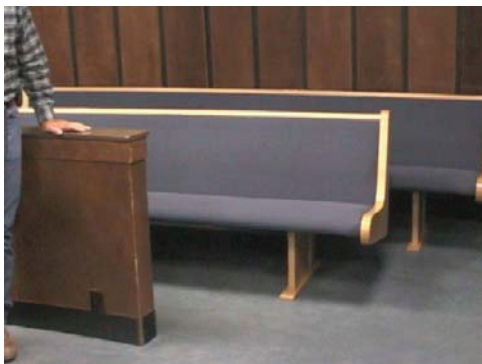
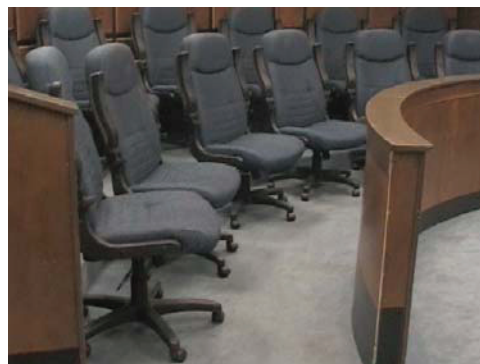
There are two main courtrooms. The smaller courtroom is very well situated for persons with disabilities. The front row of the jury box is accessible as are counsel tables and the witness chair. The actual chairs used by counsel and jurors have arms which can move up to accommodate larger people. These chairs also have exceptional lumbar support. Use of this type of chair in all courtrooms (in Gila County or elsewhere) would be helpful. There is access for persons using a wheelchair to sit in the audience. The door to the court room is light weight and easy to push open.

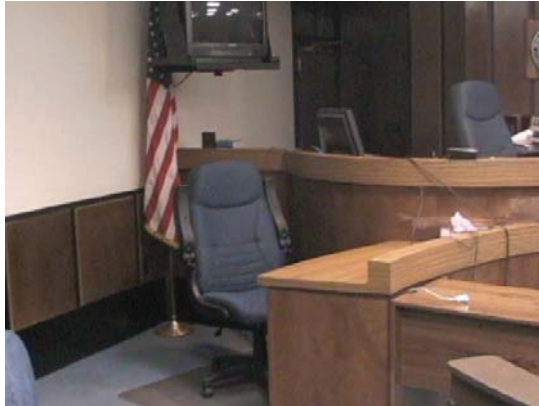
There is access through the court administrator's office to a small hearing room. We were advised that an attorney who uses a wheelchair who had used the facilities could maneuver through the court administrator's office to the hearing room.

The hearing room had moveable chairs for the witnesses and counsel. However, the room was small.
