**State Bar of Arizona Task Force on Persons with Disabilities
Accessibility Committee Site Visit
Santa Cruz County Superior Court
Nogales, Arizona**

SURVEY BACKGROUND

Facility: Santa Cruz County Superior Court, 2150 N. Congress Drive, Nogales, AZ 85628

Date: November 17, 2003

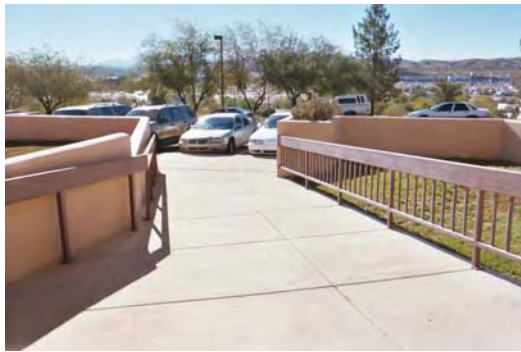
There is open parking for court personnel, visitors, jurors, attorneys and judges surrounding the building. Accessible spaces are marked.

Suggestion: It is suggested that signs be placed indicating that accessible parking is available in the back of the building as that is the most accessible entrance to the courtrooms.

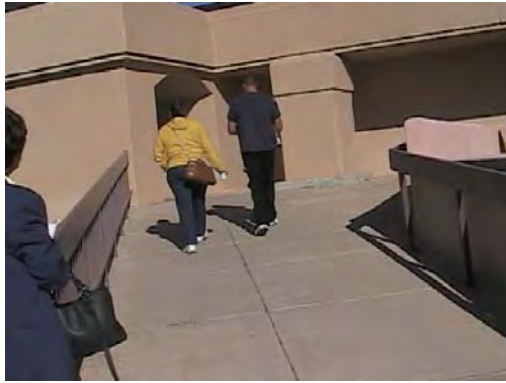
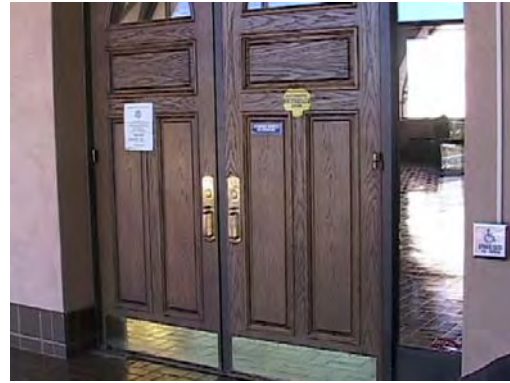
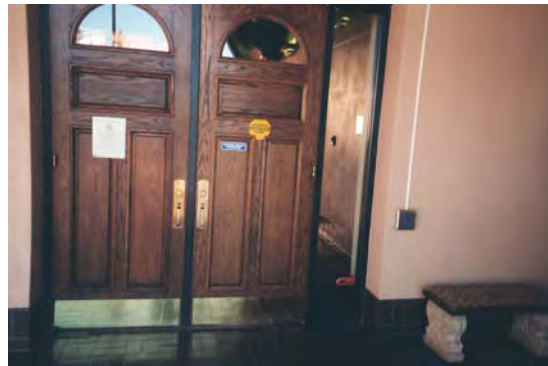
There is a ramp leading up to a side entrance for the front doors of the county complex. Unfortunately, the door to the side entrance does not have an automatic door opening button. The door at the front entrance does have such a button, but there are only stair leading to that door, and no ramp exists. In addition, once inside, there was a somewhat long path from the front door to the back of the building to enter through security and take an elevator up to second floor to reach the courts. Access to the courts could be made through the back of the building leading directly to the second floor. A ramp does lead to the door at the back from the parking lot.

Suggestion: Perhaps the easiest change would be to retrofit the side door in the front entrance to provide for an automatic door opener for the door which is accessible by ramp. In addition, if security could be arranged, it might be possible to have access for persons with disabilities from the back door, directly onto the second floor, thus alleviating the long path through the corridors of the first floor to security and the elevator to the second floor courtrooms. However, there are several doors through which one must pass in order to get from the outside to the actual corridors for the court rooms. The passage way would need to be marked carefully, and perhaps some doors could be removed. Finally, a sign, indicating that disability access to the second floor can be made from the back of the building, could be placed at the front and sides of the building.

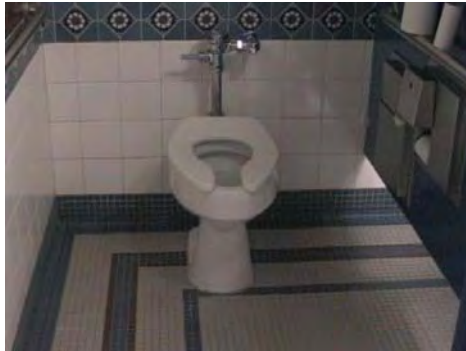
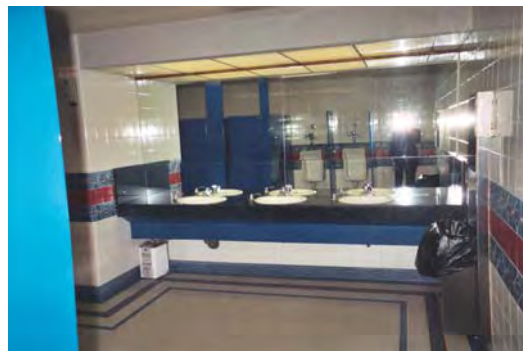
There are restrooms on both the first and the second floor which have facilities for persons with disabilities. The men's restrooms were very well set up and easily accessible for persons with disabilities. While the women's restrooms had stalls for persons with disabilities, they were long and narrow and might present difficulty for a person in a wheelchair. The wash basins in both men's and women's facilities were well placed and had wing faucets, making them easier to turn on.

Suggestion: It might be possible to widen one stall in each of the women's bathrooms by removing the door to the non-accessible stall next to it and removing the toilet from that stall.

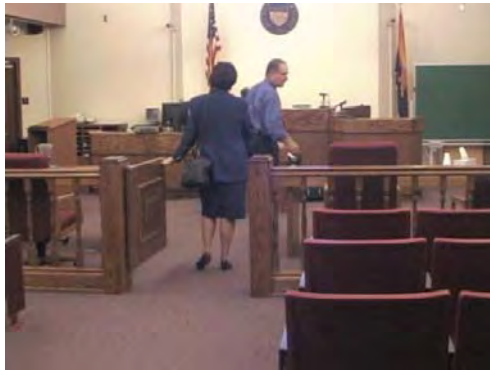
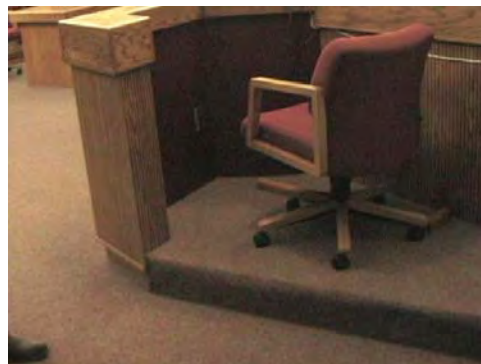
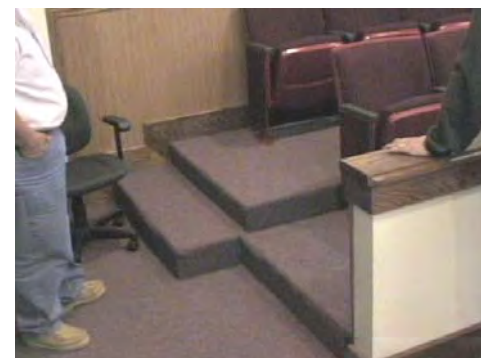
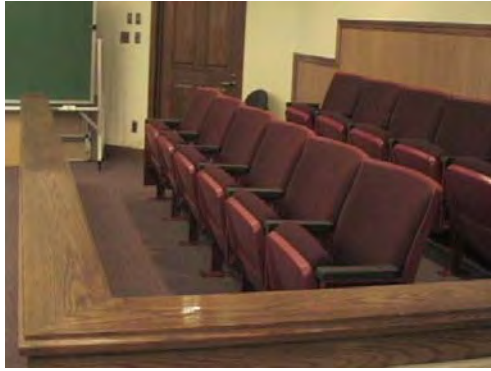
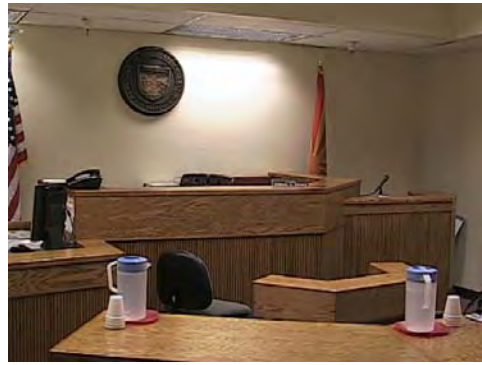
A. Courtroom A, the largest, was accessible for lawyers and for spectators. The witness chair and the jury box both had steps in order to sit. While we were there, Mr. Espinoza, who is in charge of all alterations in his capacity as head of facility management, discussed immediate steps which could be taken to bring the witness chair flush with the floor, to shorten the judge's bench height so the judge could observe the witness and to remove one or two seats from the jury box so that a person using a wheelchair could access that space.

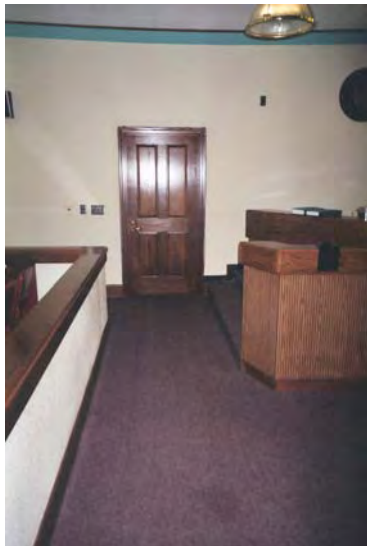
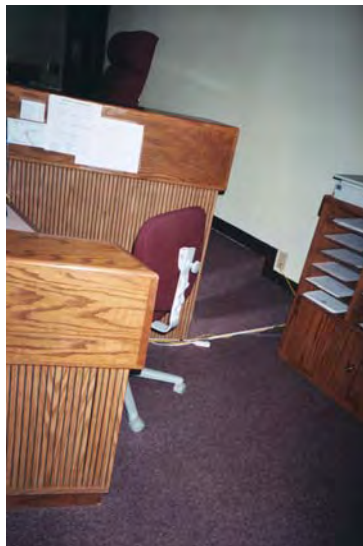
B. Courtroom B had the same issues with respect to the step up for the witness box. There was not step up for the jury box, but a juror using a wheelchair would have to sit outside the actual box unless seats are removed. The space for attorneys was adequate, and spectators could sit at the end of rows.
