**State Bar of Arizona Committee on Persons With Disabilities
Accessibility Committee Site Visit
Mohave County Superior Court
Bullhead City, Arizona**

SURVEY BACKGROUND

Facility: Mohave County Superior Court, 2225 Trane Road, Bullhead City, Arizona

Date: June 4, 2004

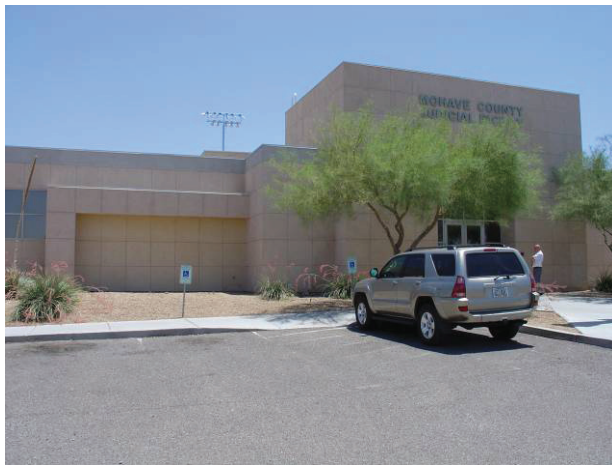
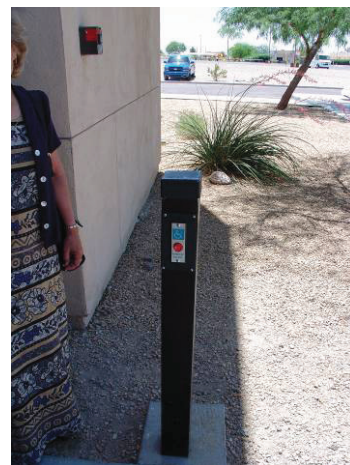
The team noted visible and height appropriate pushbuttons for the front doors. When activated, these doors opened for what seemed an adequate amount of time to allow mobility-impaired individuals to safely pass through.

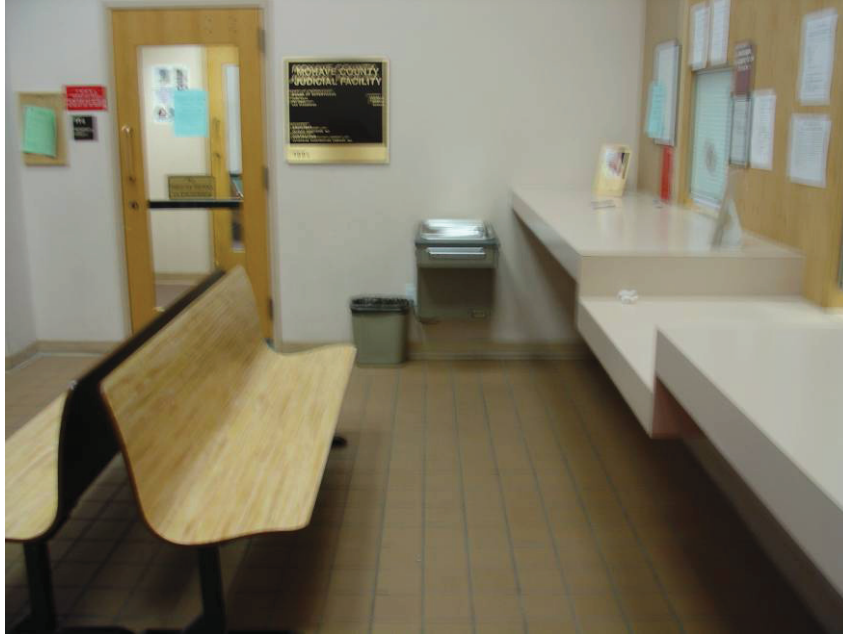
The main lobby has some room to maneuver, although long banks of seating may make this a challenge for some. The lobby is flanked by an enclosed counter area, and one counter was an appropriately lowered height for access by individuals using a wheelchair.

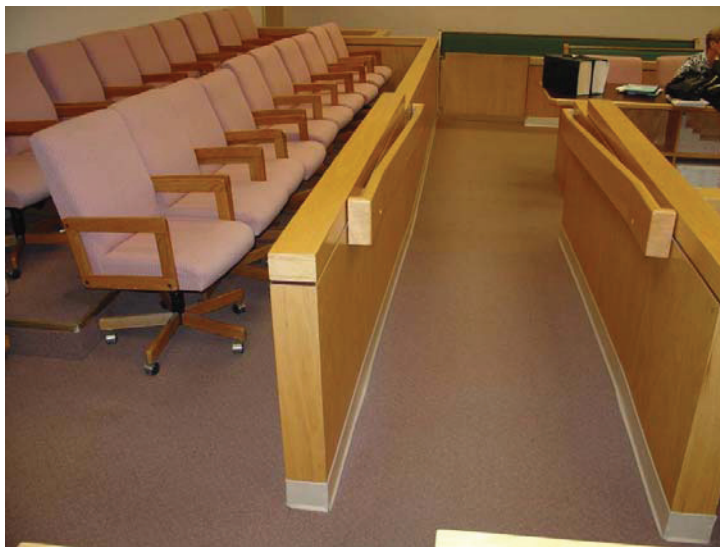
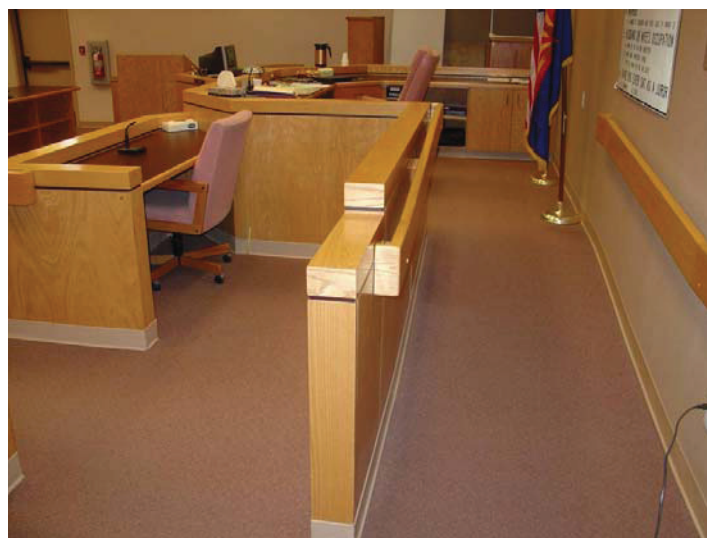
This courtroom is entered by jury members via ramps outside the courtroom. There are also ramps to the bench, the witness box, and the jury box, making this a very accessible facility. The jury box holds moveable chairs, which allow maximum flexibility and maneuvering. Ms. Sperando noted that in the event a juror used a wheelchair, one of the regular jury chairs could just be moved out to easily accommodate the wheelchair. Ramps and open space in these areas appear to be fully accessible.

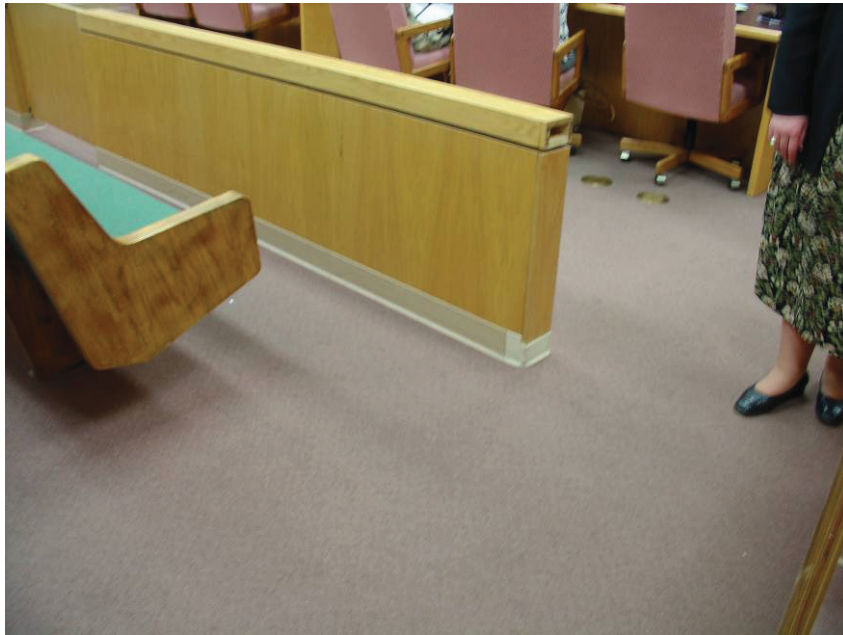
The public access doors to this courtroom are difficult to maneuver, and could be particularly so for an individual with a disability. There are no pushbuttons to otherwise activate these doors. The team recommended that the tension in these doors be checked and lowered to the five-pound level, if possible. There is church pew style seating for the public, and Ms. Sperando advised that a member of the public with a disability can be easily accommodated in open space and cut out spaces in and around this seating. The attorney areas are very open with moveable seating. Given their flexibility, these areas also appear to be fully accessible.

- Install a sign in the lobby that directs individuals requiring assistance and/or accommodation to a staff point of contact.
- Check tension on doors and, if possible, reduce tension to 5 pounds to allow more ease in opening.
- Exchange handles on restroom faucets to the flipper type.

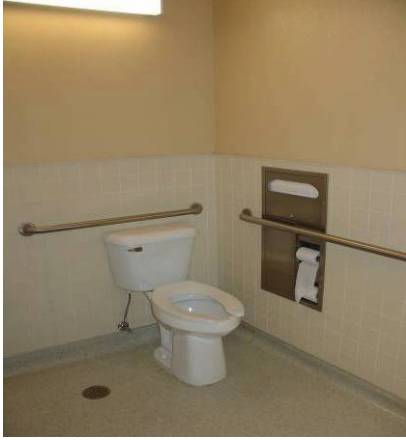
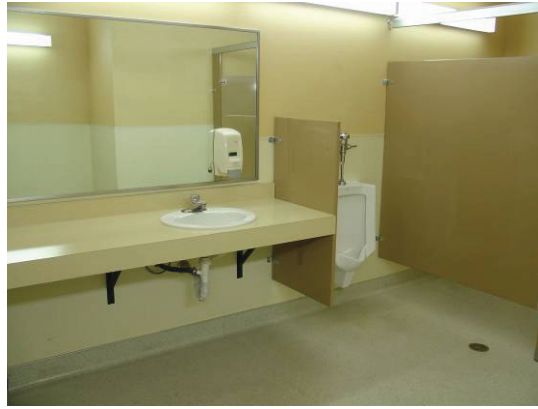
The women's restroom off the lobby has easy wheelchair access. There is a large stall with bars that would allow for side-to-side transfer, if needed. The counter has been lowered and under-counter pipes have been insulated for the safety and benefit of a person using a wheelchair. Soap and paper towel dispensers are all at an appropriately lower height.

The faucets use handles that must be pushed and held down to keep water running. These can be difficult for some individuals with a mobility disability to use, so the team suggested that handles be exchanged with larger flipper handles.

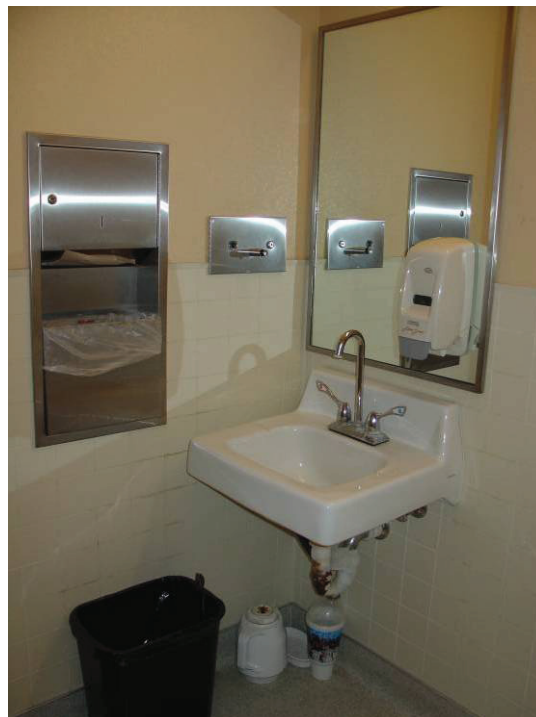
On the plus side, the courthouse has installed fully accessible employee restrooms in the administration area. Ms. Sperando explained that members of the jury also use these restrooms when needed.
