**State Bar of Arizona Committee on Persons With Disabilities
Accessibility Committee Site Visit
Greenlee County Superior Court
Clifton, Arizona**

SURVEY BACKGROUND

Facility: Greenlee County Superior Court, P. O. Box 1027 (5th Street/Webster), Clifton, Arizona 85533

Date: Tuesday, May 25, 2004

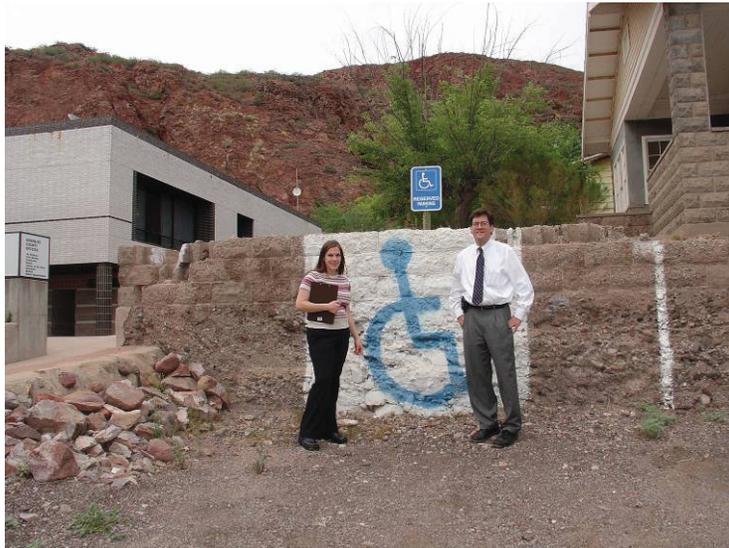
A small (6 – 8 spaces) parking lot is located across the street from the main courthouse entrance. The lot is unpaved and is also sloped. There is one designated accessible space which is currently utilized by a court employee who has a disability.

Suggestion: Designating an additional accessible space in the small parking lot for the general public is recommended. Signage for this purpose is relatively inexpensive. Barring budgetary restraints, it would be ideal if this lot was paved and on a more even grade for ease of mobility. As previously noted, an expansion of and improvement to the lot is already planned.

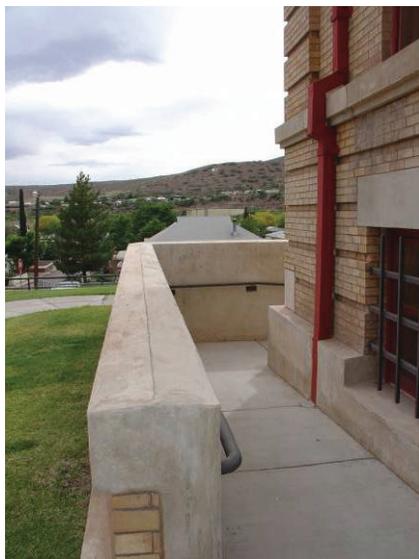
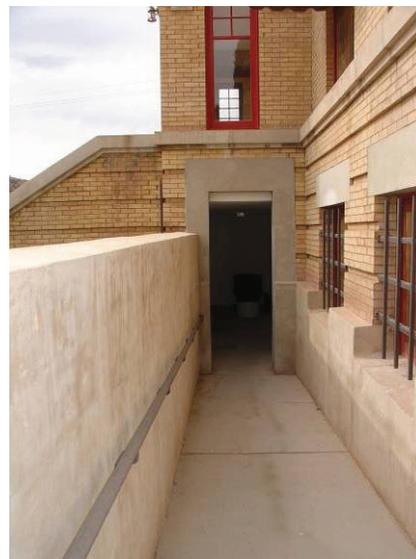
One enters the courthouse up a flight a stairs. Alternatively, a ramp extends around the corner of the building which descends to a lower level floor of the courthouse. Doors at both of these entrances are heavy and fast closing.

Suggestion: A simple readjustment to the tension on both doors would provide easier access.

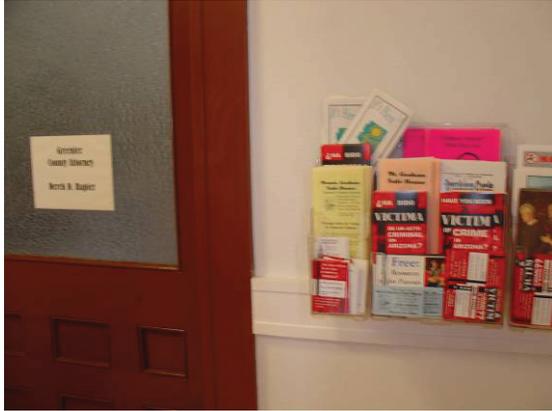
Pamphlets providing information on court and social services-related programs were available in racks in the hallway by the county attorney's office. The team was not aware of any specific pamphlet detailing court-related services for persons with disabilities. As previously

noted, hearings occur daily in the courtroom. Notices sent to hearing participants could include the name and phone number of court staff, if this information is not already included, who would be able to make arrangements for special accommodations.

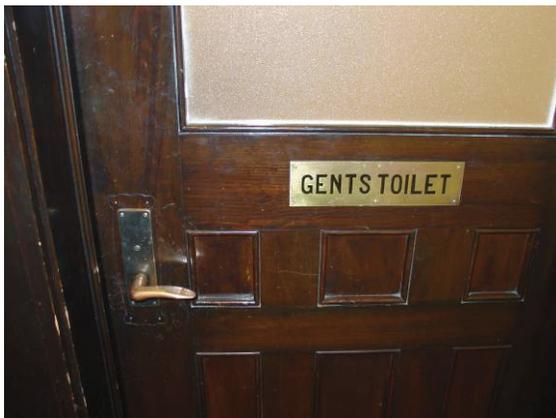
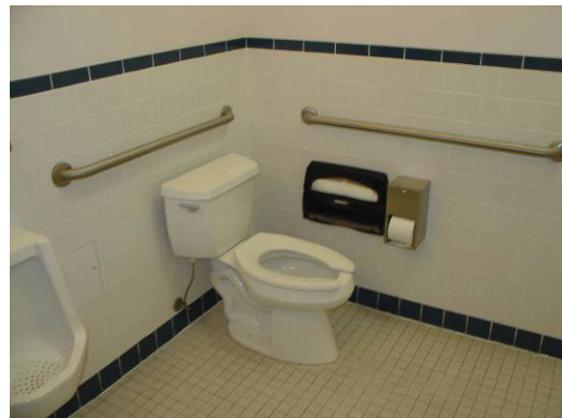
The restrooms on the lower level/first floor are not totally accessible; however, accessible restrooms are located on the second and third floors. These upper level restrooms, which used to have two stalls, now feature one toilet (no stall) which provides more than ample space to accommodate a person using a wheelchair. Towel and soap dispensers are at low levels and grab bars are available. The doors have wing handles.

Suggestion: Post signage (especially by the restrooms on the lower first floor) directing individuals to the accessible restrooms which are located on the second and third floors. Such

signage is inexpensive and would be helpful and informative to those arriving or utilizing the conference room on this floor.

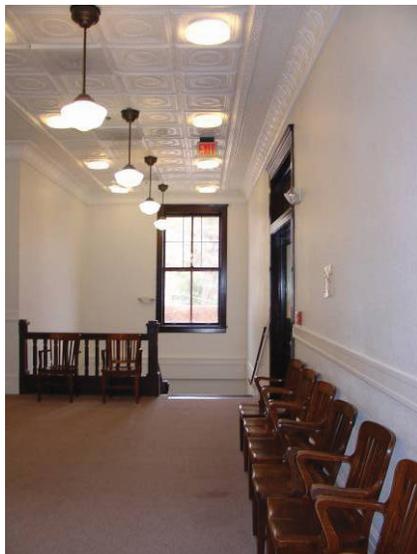
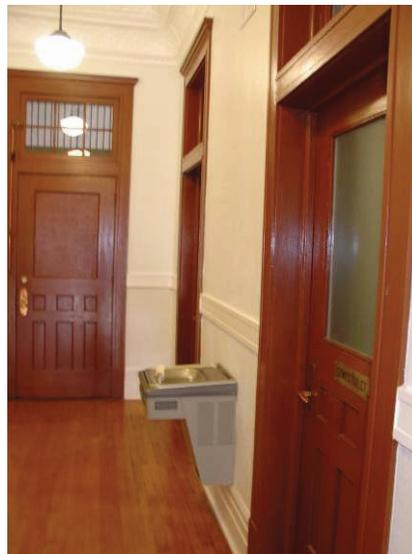
The hallways are wide and easily maneuverable. There is, however, a slight bump or rise in the hallway on the second floor, by the law library – a sort of a mini ramp – connecting two hallways. The hallway was narrower at this juncture.

A drinking fountain was at an accessible level and functional.

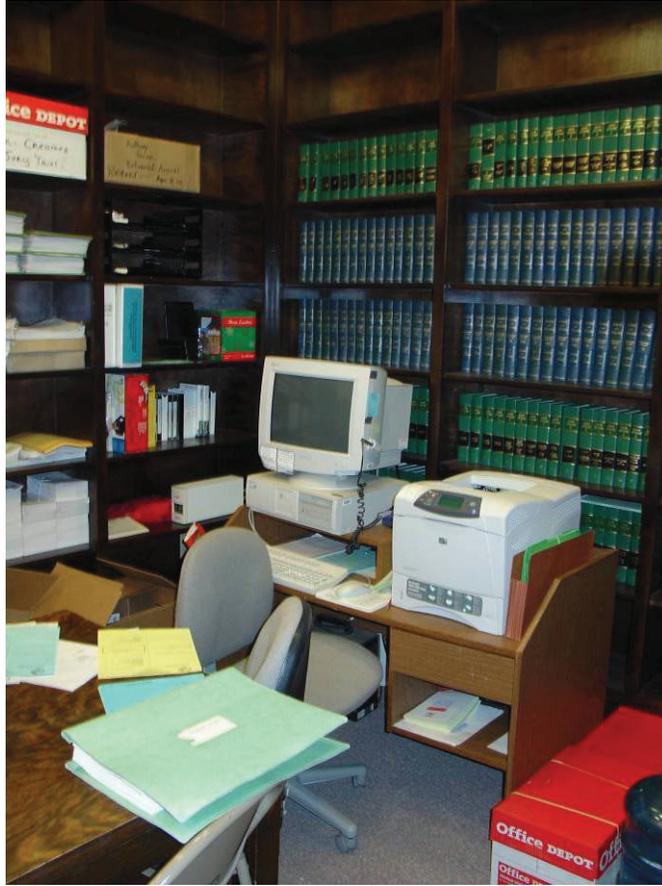
The tight quarters of the law library, with its myriad of bookcases, a small table and a couple chairs, was hard to maneuver for an able-bodied individual. One could conduct legal research on the CD Roms that were made available at a computer terminal. This room is not accessible to a person using a wheelchair and there is no other available space within the courthouse that could house the library.

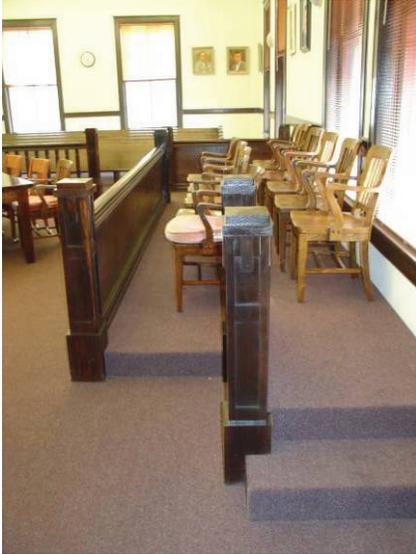
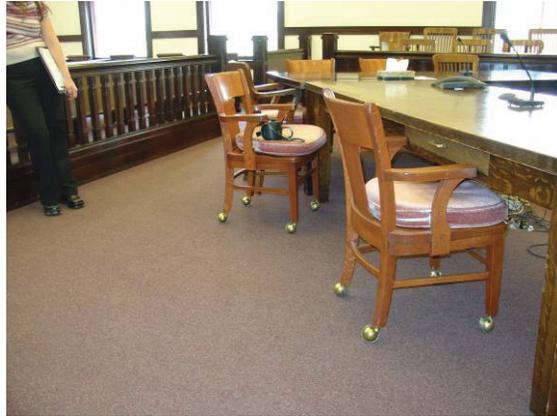
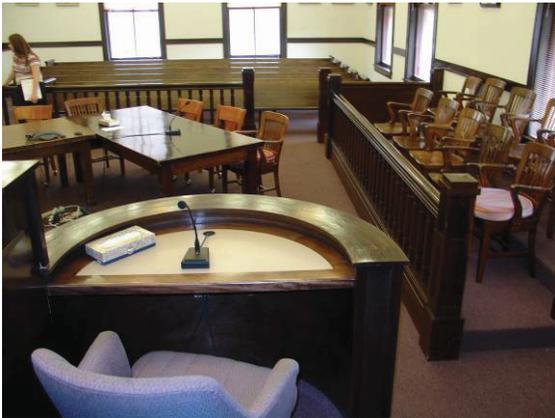
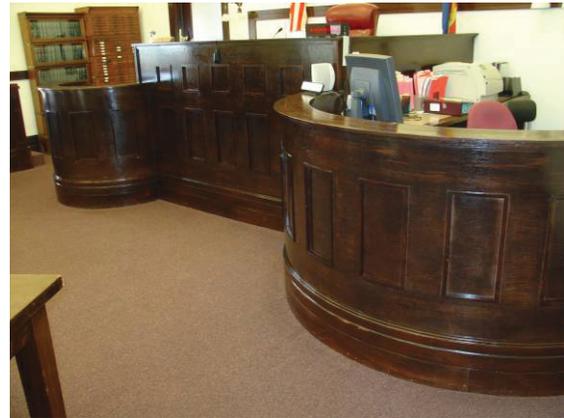
This turn-of-the-century courtroom is impressive and elegant. The room is well lit. Chairs around the defense and plaintiff's tables are on casters and easily moveable. Chairs in the jury box can also be removed to accommodate a person using a wheelchair, scooter or walker, however, there is no ramp into the box (but a step into the box). In order to maintain its historical significance, some renovations were not done and there are some challenges in this room for individuals with disabilities.
